## STRUCTURAL ASSESSMENT REPORT

<b>Project:</b> Kitsap County Suquamish WWTP	<b>Purpose:</b> Structural Evaluation
<b>Location:</b> 18000 Division Ave NE, Suquamish, WA	<b>Date:</b> February 17, 2023
<b>CG Project:</b> 23029.10	<b>Report:</b> 1
<b>Client:</b> Consor	<b>Field Rep:</b> Joe Galusha, PE, SE, LEED AP

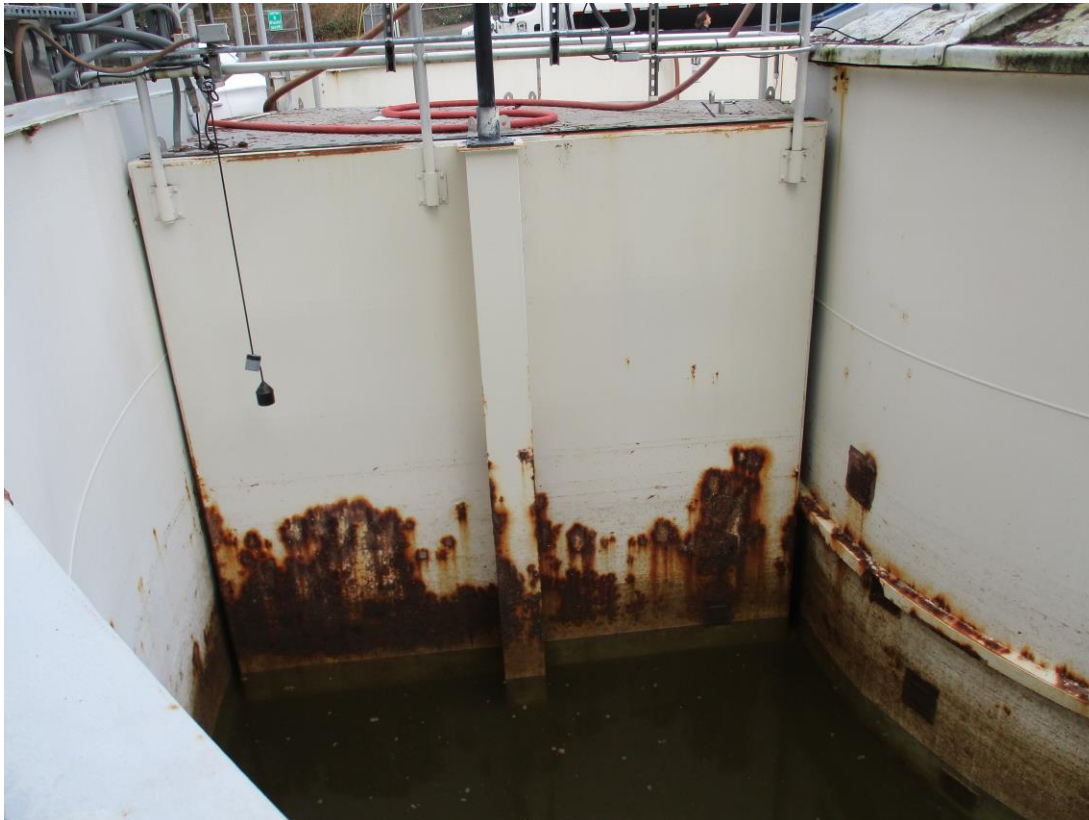
1. **EQ Basin / Sludge Storage Tank** – Constructed in 1975, the EQ basin / sludge storage tank was the oldest structure that was observed at the site. The visible portions of the basin appeared to be structurally sound, however, we observed considerable surface corrosion of the painted steel at the tank walls. Several photos at the end of this report show the extent of the corrosion that was observed. In addition to corrosion, the concrete access stairs showed signs of settlement and there was a large crack at the top tread caused by the settlement.
2. **Process Building and SBR Basins** – The 1997 process building and SBR basins, which were constructed primarily of concrete, were observed to be structurally sound. The liner for one of the SBR basins appeared to be compromised on one end and surface corrosion was observed on

Photo 2 – Corrosion at the EQ Basin

- As discussed, extensive surface corrosion was observed at the 1975 EQ basin. It is our opinion that the corrosion should be addressed within the next 1-3 years. Because there is a corrosion specialist on the design team, we will defer specific recommendations to them, given their expertise in the field. However, we plan to work together on a coordinated repair plan that will likely include the addition of new welded plates in areas where the corrosion has substantially reduced the base material.

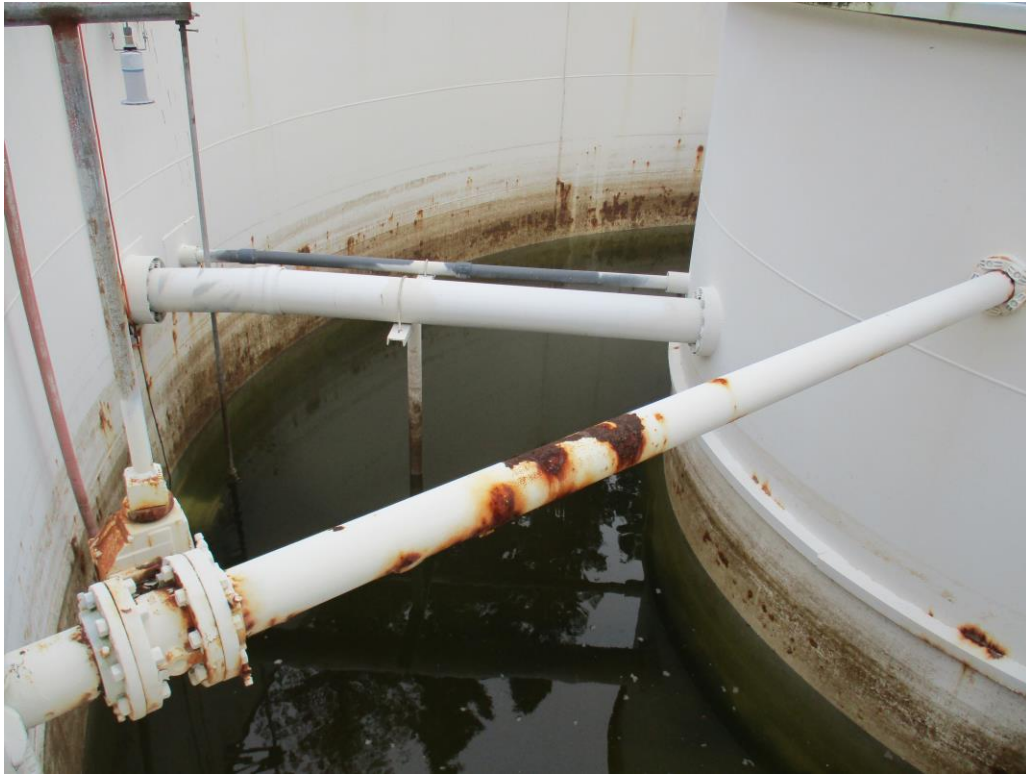
**Photo 3 – Corrosion of Piping at the EQ Basin**

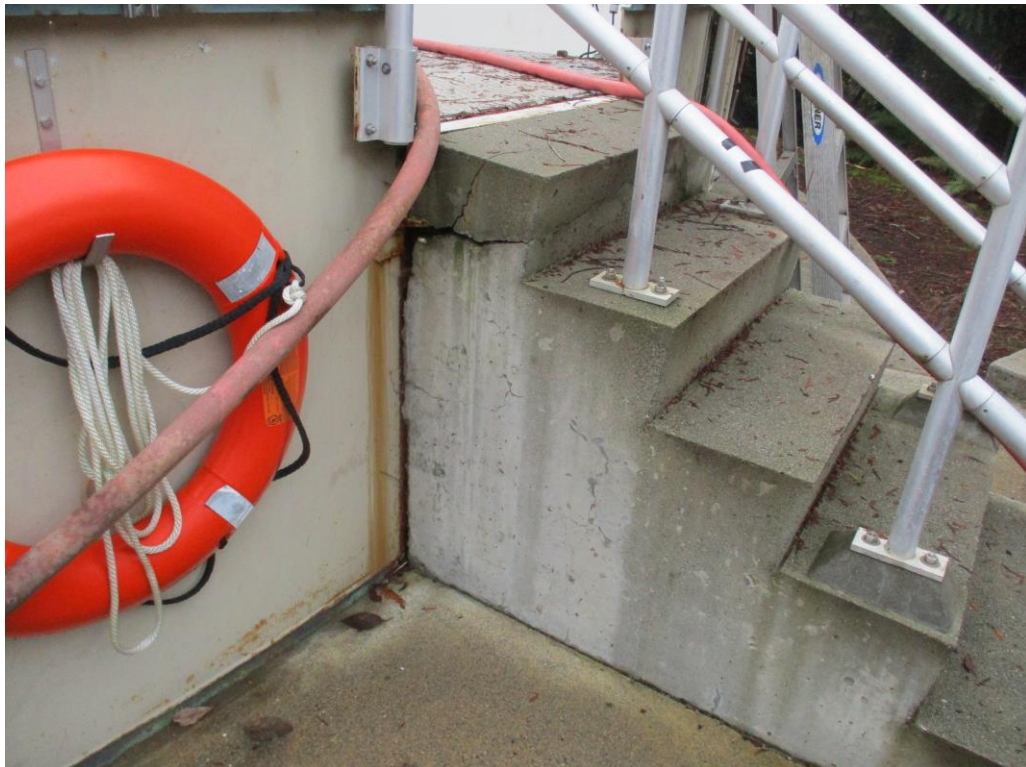
**Photo 4 – Stair Cracking Due to Settlement at the EQ Basin**

- Due to apparent settlement, we recommend that the access stairs for the 1975 EQ basin be removed and replaced.
- The upcoming facility improvement project will consist of the replacement of much of the existing piping within the process building. Because the process building floors, walls, and roof structure was observed to be in good overall condition, it is our opinion that the building will have adequate strength to support new pipe supports, anchors, and wall penetration that will be associated with the piping replacement project.

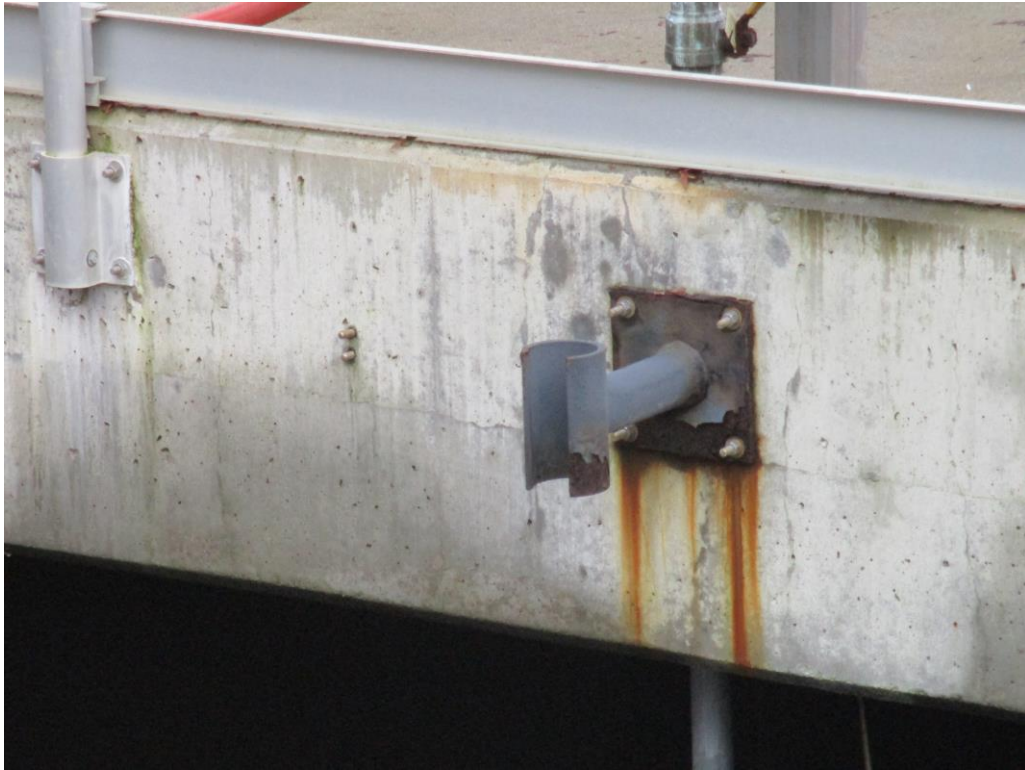
**Photo 5 – Corrosion of Metal Plate at SBR Basins**

- Surface corrosion of metals was similarly observed at the process building and SBR basins. We advise following the recommendations of the corrosion specialist, which may include replacement of corroded plates and bolts. The corrosion specialist also plans to provide recommendations for replacement of the SBR basin liners.

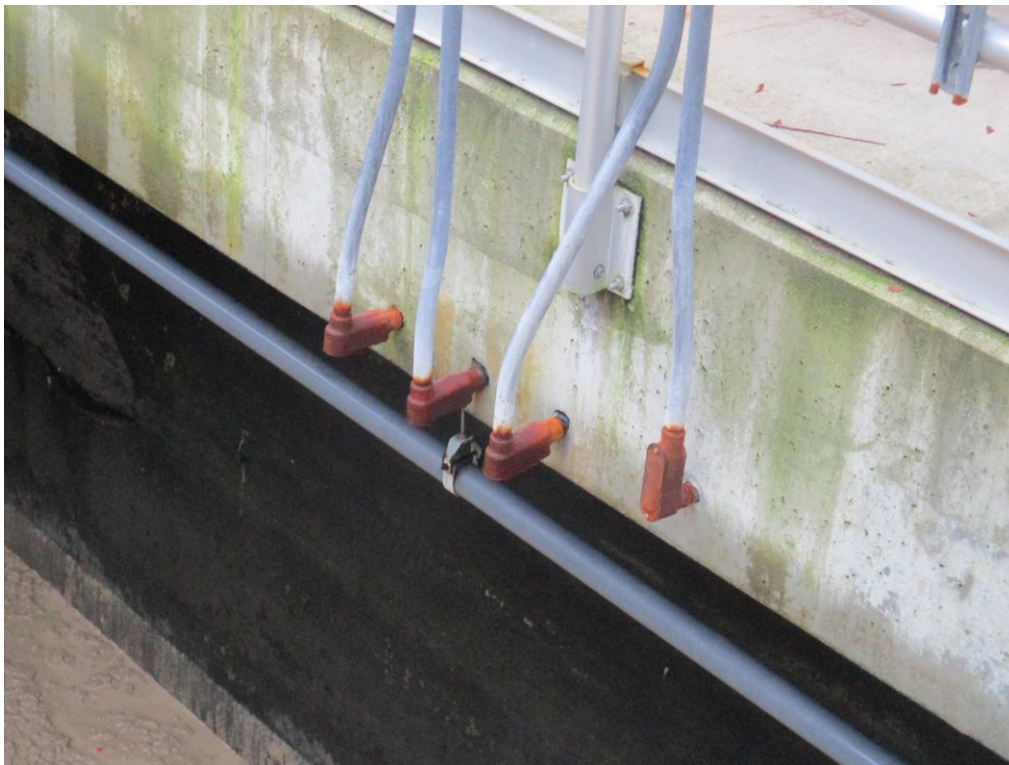
**Photo 6 – Corrosion of Metals at SBR Basins**

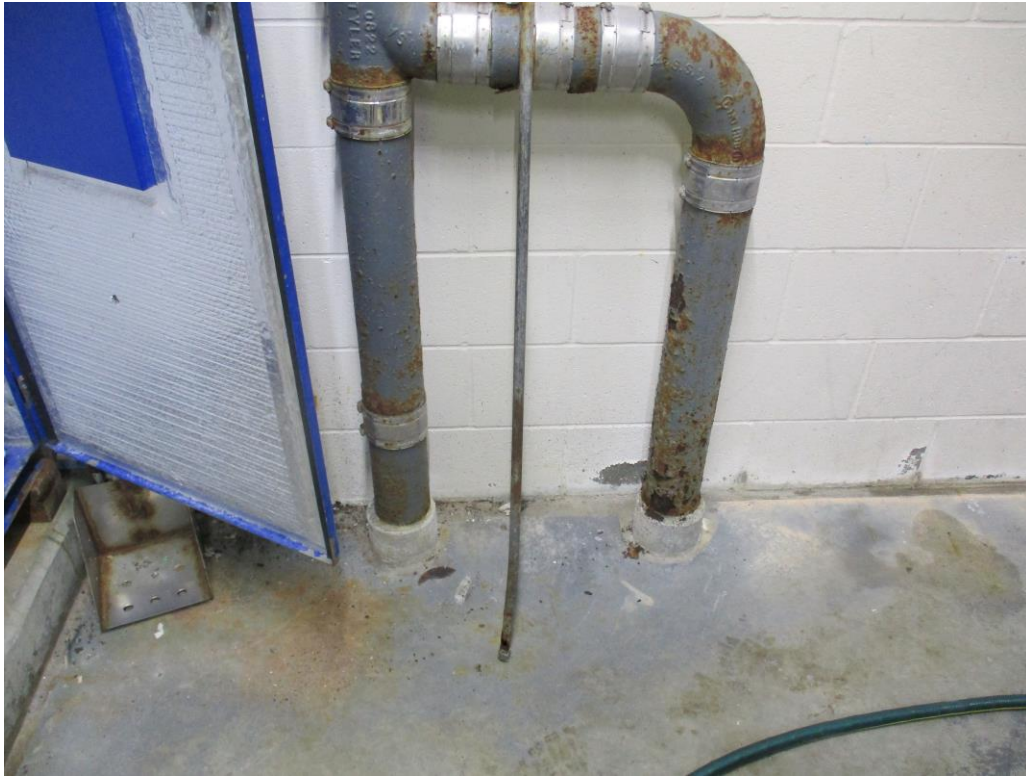
the metal components in several places as seen in the photos at the end of this report. In addition to metal corrosions, efflorescence was observed on the inside face of the CMU walls at the upper floor of the process building.

**Photo 7 – Corrosion of Metal Pipes in Process Building (Upper Floor)**

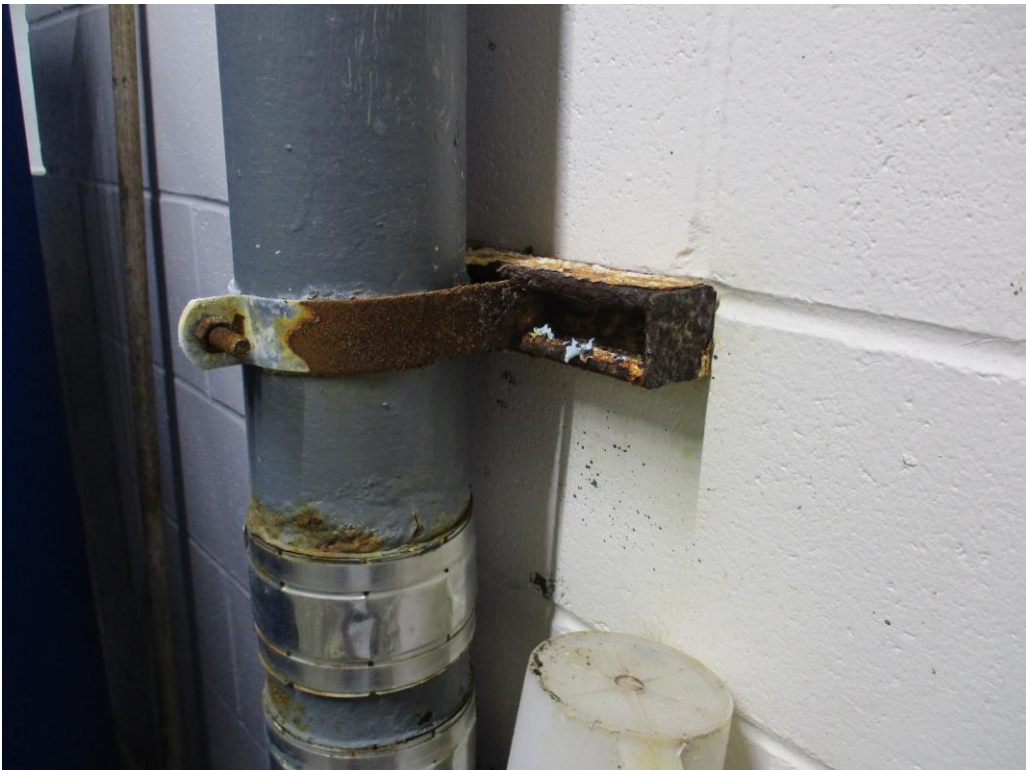
**Photo 8 – Corrosion of Metal Component in Process Building (Upper Floor)**

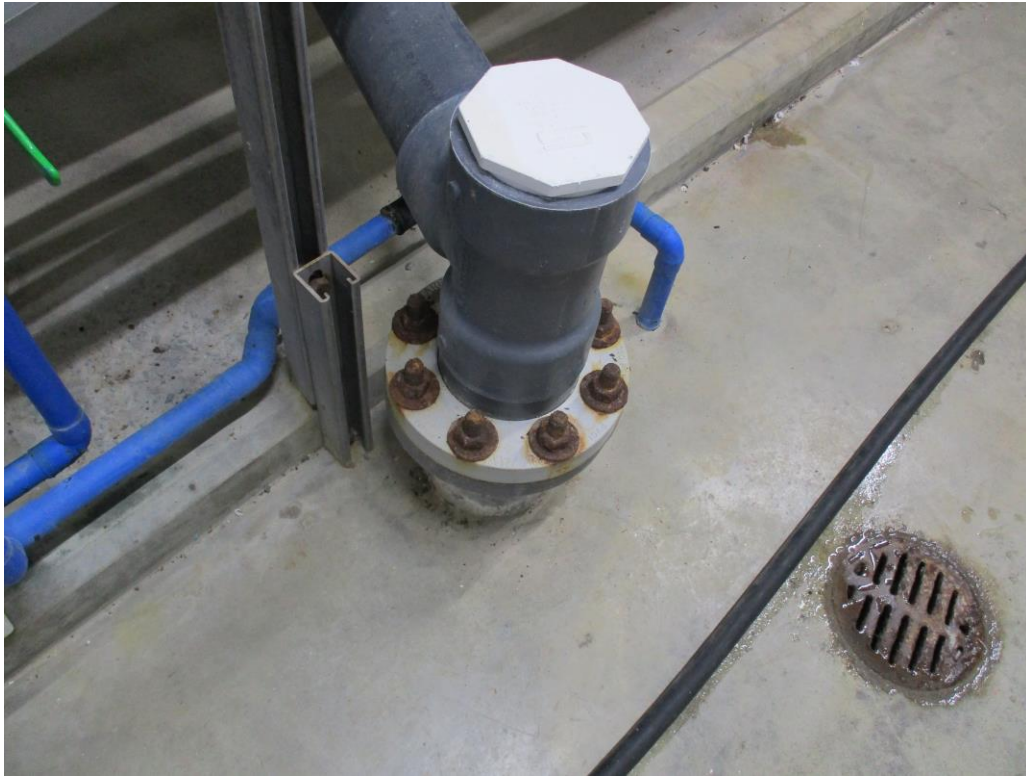
**Photo 9 – Bolt Corrosion at Process Building (Upper Floor)**

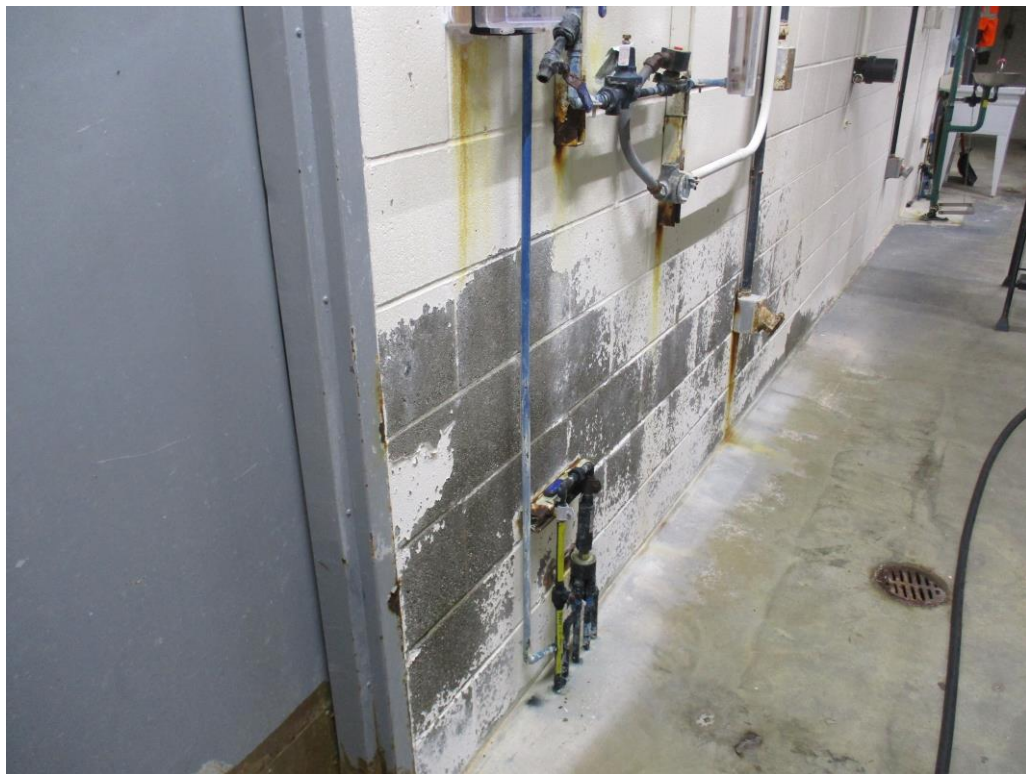
**Photo 10 – Efflorescence at Process Building (Upper Floor)**
