Point No Point

# Flood Protection Design Alternatives and Basis of Design

**Prepared for**  
Kitsap County Parks

**Prepared by**  
Blue Coast Engineering LLC

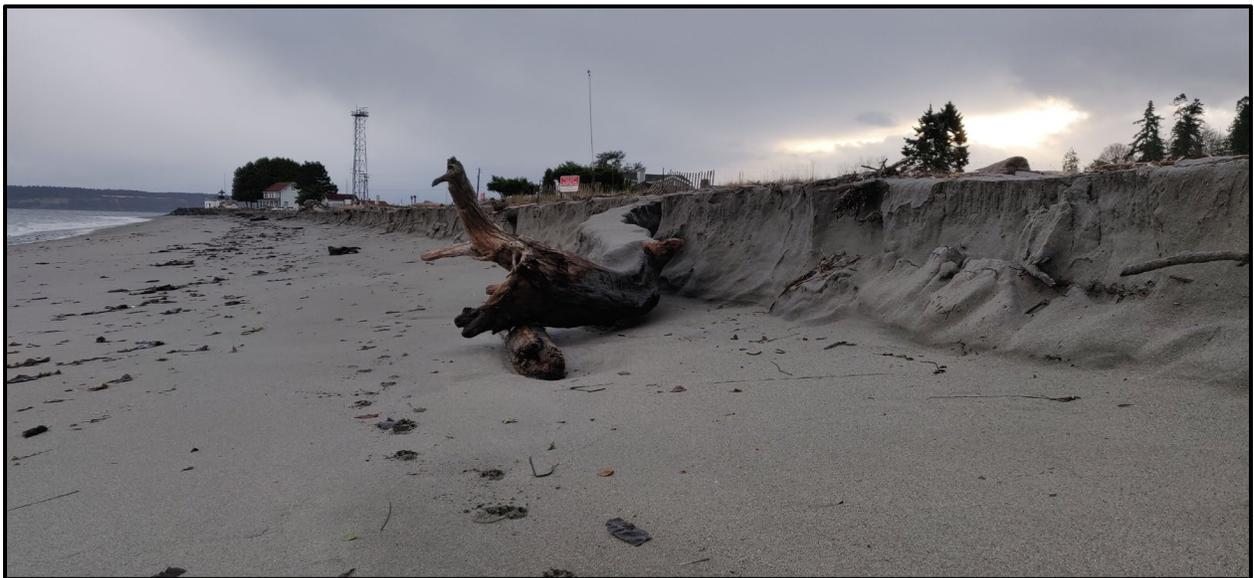
Two significant events occurred in the winter of 2022 that resulted in erosion and flooding at Point No Point Park. A strong westerly wind event in the Strait of Juan de Fuca on November 5, 2022 resulted in northerly winds through Admiralty Inlet and across the 15-mile fetch to the north and northwest of Point No Point. Although this occurred around during a mean tide (3 to 4 feet NAVD88 water surface elevation), the waves from this event resulted in the formation of a 2- to 3-foot scarp of the upper beach at approximate elevations of 8 to 9 feet NAVD88 (Figure 2-2). The scarp was observed along the length of the north beach and the east parking area.

**Figure 2-2. Photograph of flood damage to north beach, November 2022 (source: Andrew Nelson, Kitsap County).**

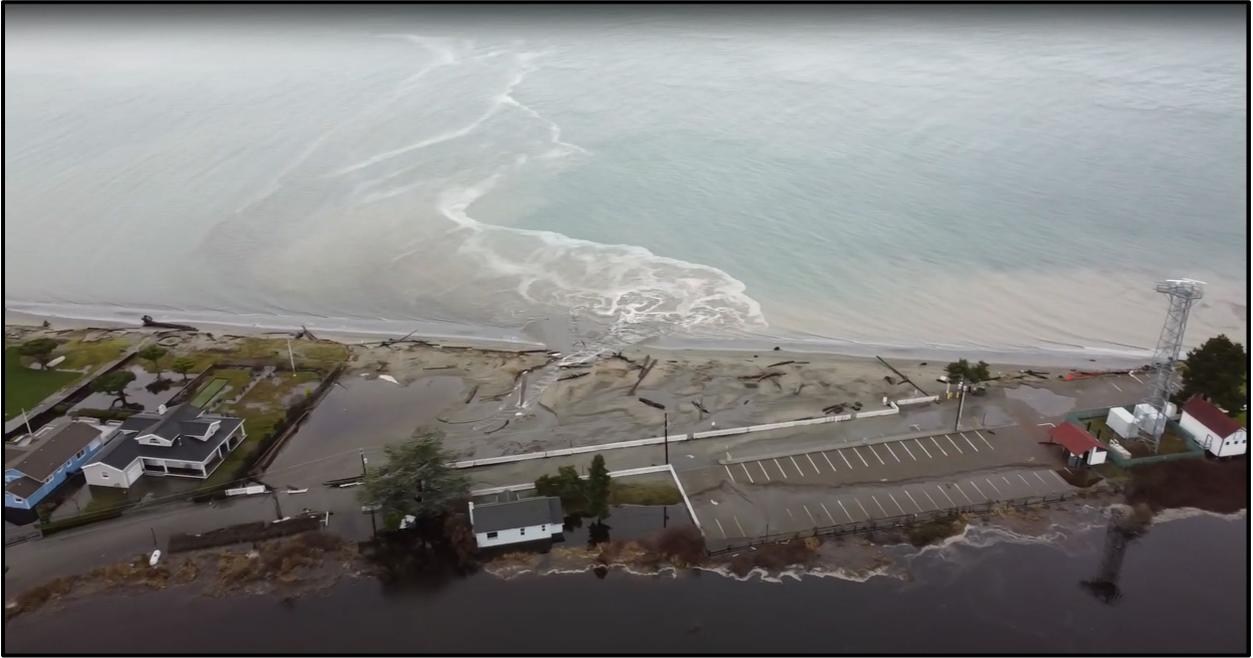
**Figure 2-3. Photograph of flood damage to north beach, December 2022 (source: Darren Gurnee drone video).<sup>5</sup>**

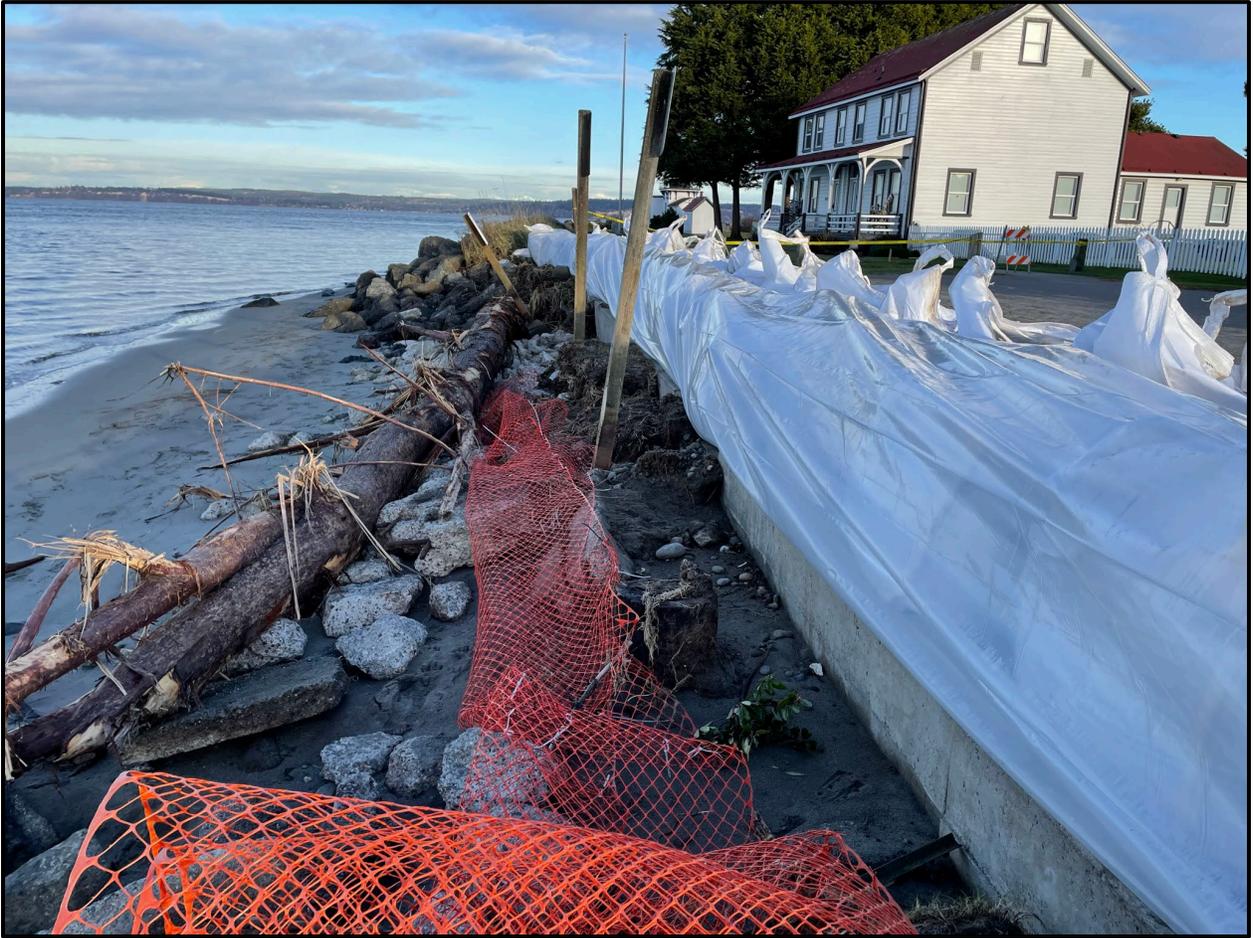
Beach erosion caused several of the parking signs at the east parking area to fall over and resulted in exposure of the base of the curb between the shoreline and the east parking area (Figure 2-4). Erosion in front of the east parking area adjacent to the rock revetment appears exacerbated by the hardened structure (an end effect from the revetment). The rock revetment appears to be in poor condition and is lacking a proper rock gradation, a filter layer, and a geotextile fabric. Pumping of

**Figure 2-4. Photograph of flood damage to east parking area, December 2022.**

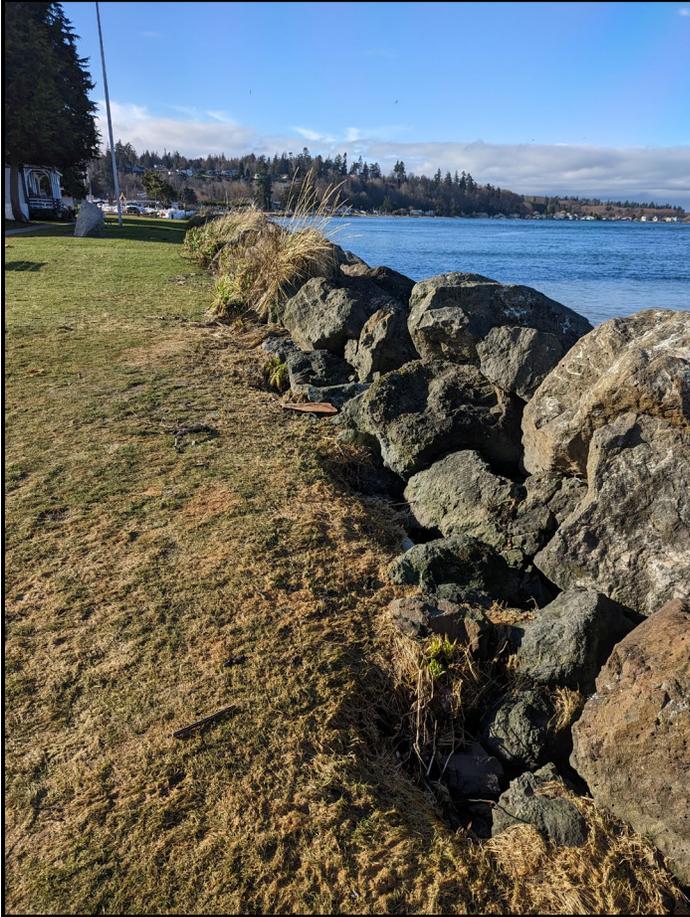
Minor damage to the upland was observed behind the existing riprap near the lighthouse as a result of high tides and wave action on December 27, 2022. Figure 2-5 shows an example of the upland loss of soil and lawn area due to erosion through the excess void spaces in the existing revetment and as a result of overtopping.

**Figure 2-5. Photograph of failing armor rock revetment, January 2023.**

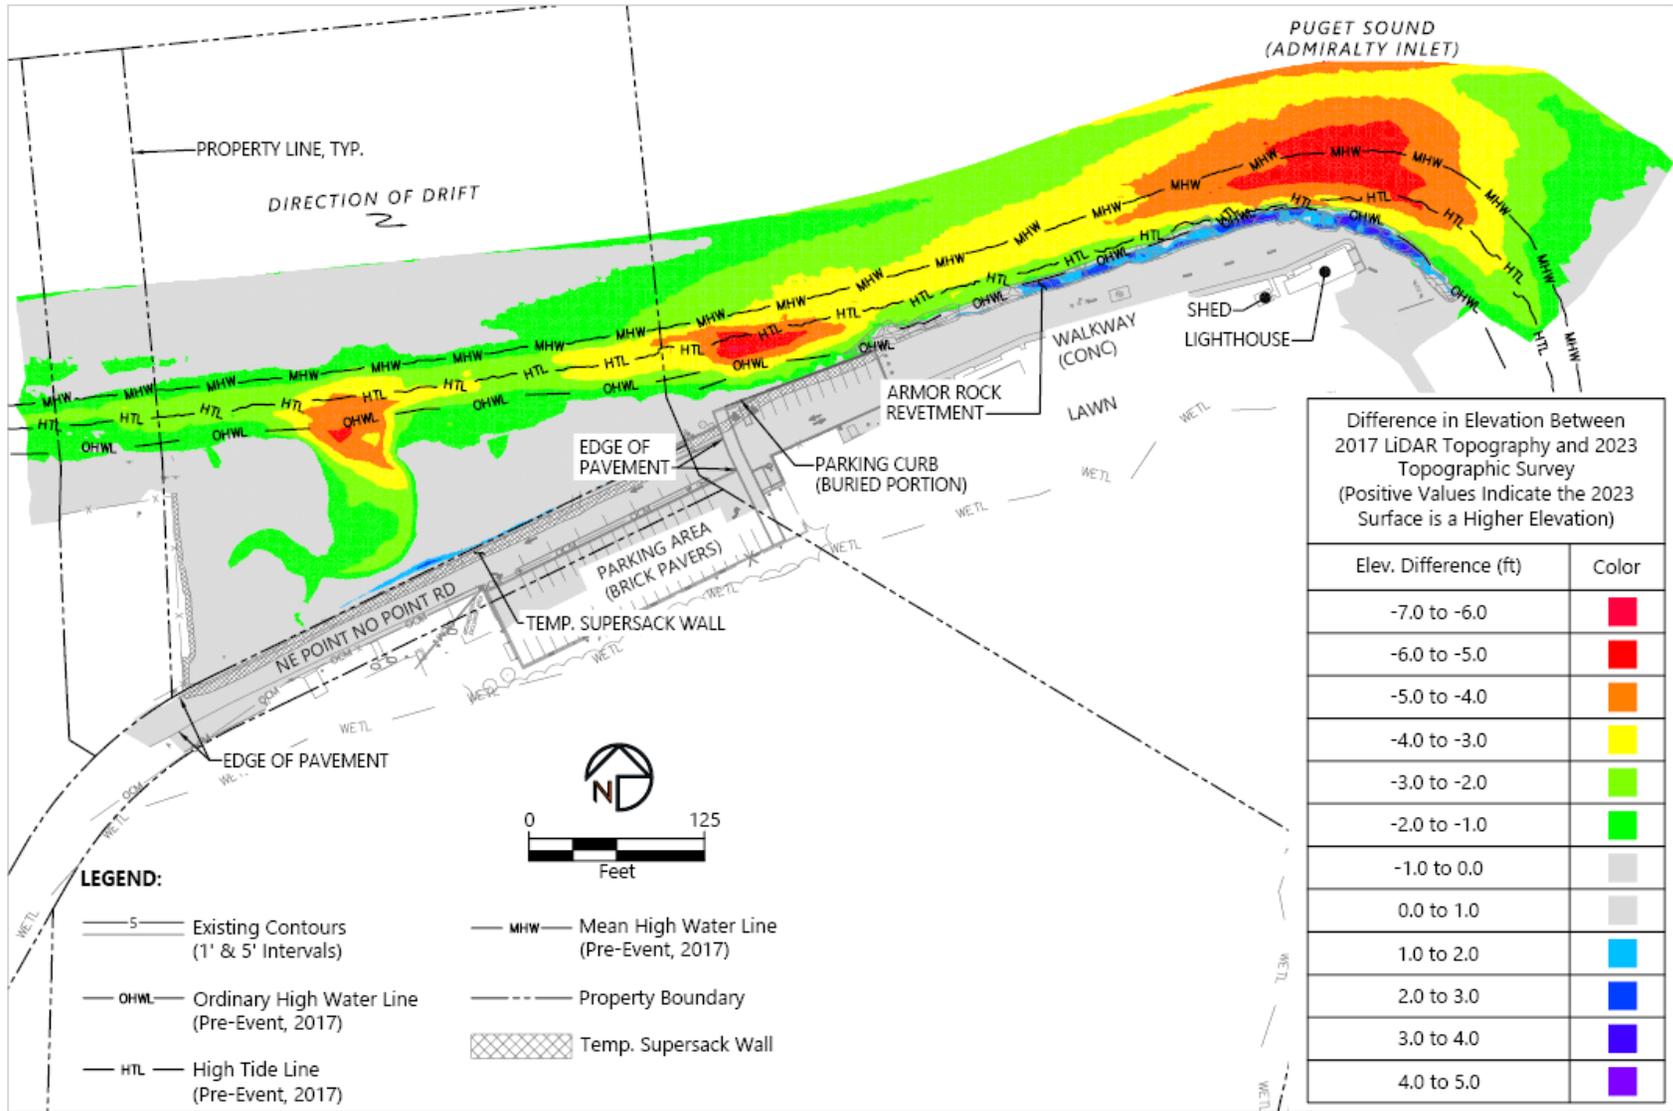
An analysis of topographic changes was completed for the north beach and shoreline using a comparison of the 2017 LiDAR topographic dataset to the recent (2023) Kitsap County topographic surveys. The comparison (Figure 2-10) shows 1 to 3 feet of lowering along the top of the beach with higher amounts (4 to 5 feet) where the channel breach occurred. The most erosion occurred in front of the east parking area. Overall, the total volume change from 2017 to 2023 within the survey area was 13,000 cubic yards (CY) of material. This is equivalent to 2,600 CY per year, or approximately 2.3 CY per foot per year of shoreline (averaged over 1,150 linear feet)

**Figure 2-10. Elevation difference map (2017 LiDAR vs 2023 topographic surveys).**

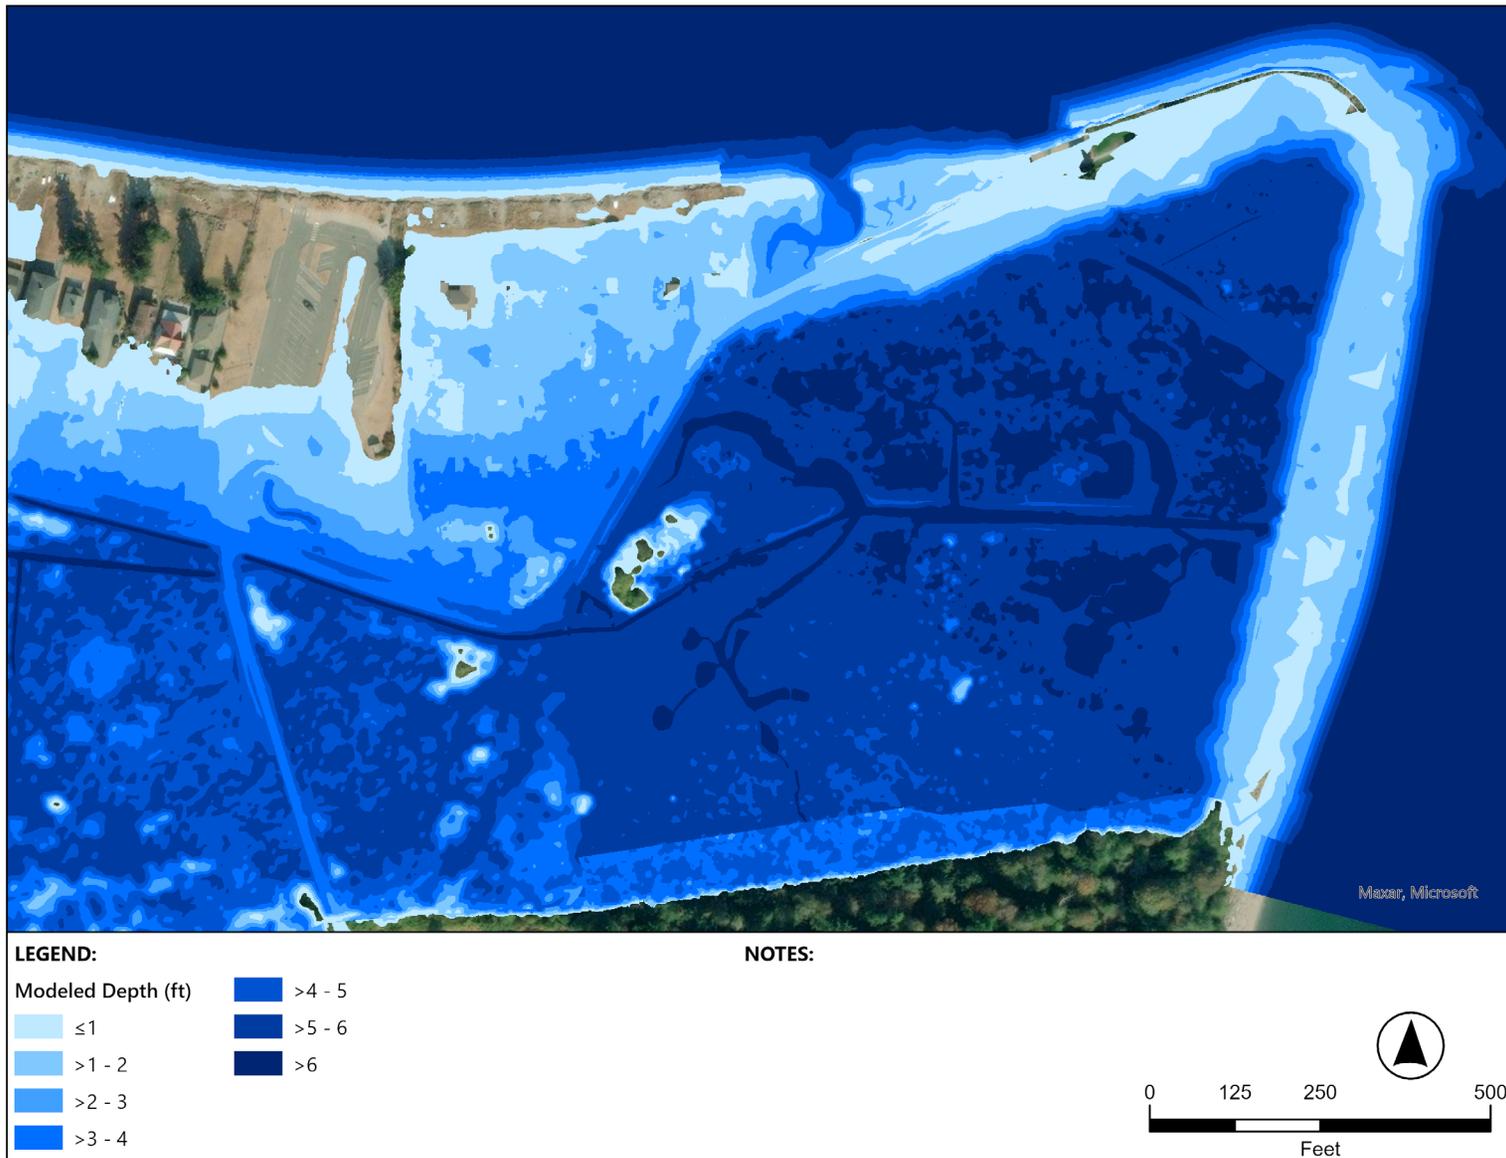
The December 27, 2022, event was simulated in the model using the estimated water surface elevation (11.8 ft NAVD88) for the site. The model predicted significant overtopping of the north beach (as was observed on December 27) as well as significant overtopping of the barrier beach on the eastern shoreline of the park. The model was then used to understand the sources of the flooding in the park and quantify contributions from various sources (surface water flow, stormwater direct runoff, groundwater inflow, precipitation and indirect stormwater inflow, and overtopping during wind-wave events).

**Figure 2-13. Predicted maximum water depth and flooding during the extreme water level event on December 27, 2022. Dark-blue shading indicates areas of maximum inundation.**

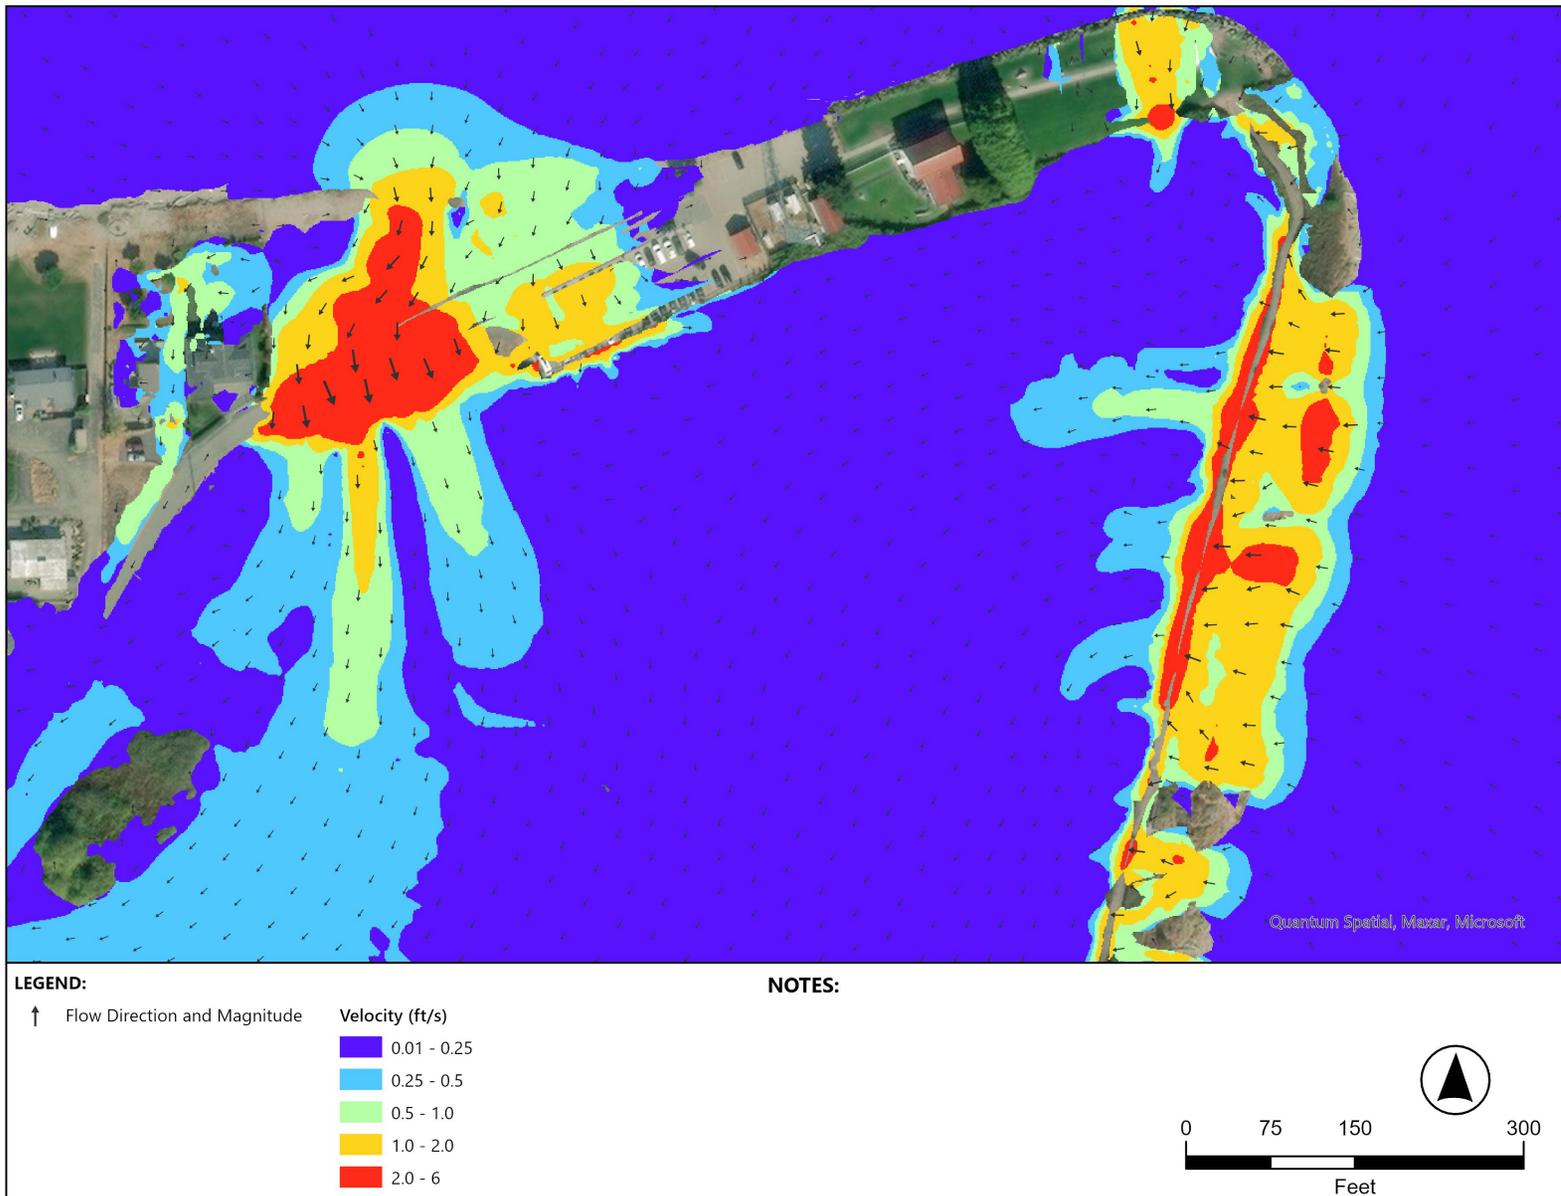
Output from the hydraulic model shows extensive flooding and very high predicted flow velocities along the northern and eastern shoreline of the park (Figures 2-13 and 2-14). There was also extensive overtopping across the eastern shoreline, but the velocities were lower because the flow was spread out across the shoreline and not focused in a small area. The northern and eastern shorelines each contributed approximately 1/3 of the flood volume observed on the road with the remainder being the result of precipitation and surface water inflow from the unnamed creek that feeds into the southwest boundary of the park. The goals of this project will not address flooding related to precipitation and surface water inflow from the creek.

**Figure 2-14. Predicted maximum overtopping velocities during the extreme water level event on December 27, 2022. Red shading indicates areas of highest velocities.**
