Point No Point

# Flood Protection Design Alternatives and Basis of Design

**Prepared for**  
Kitsap County Parks

**Prepared by**  
Blue Coast Engineering LLC

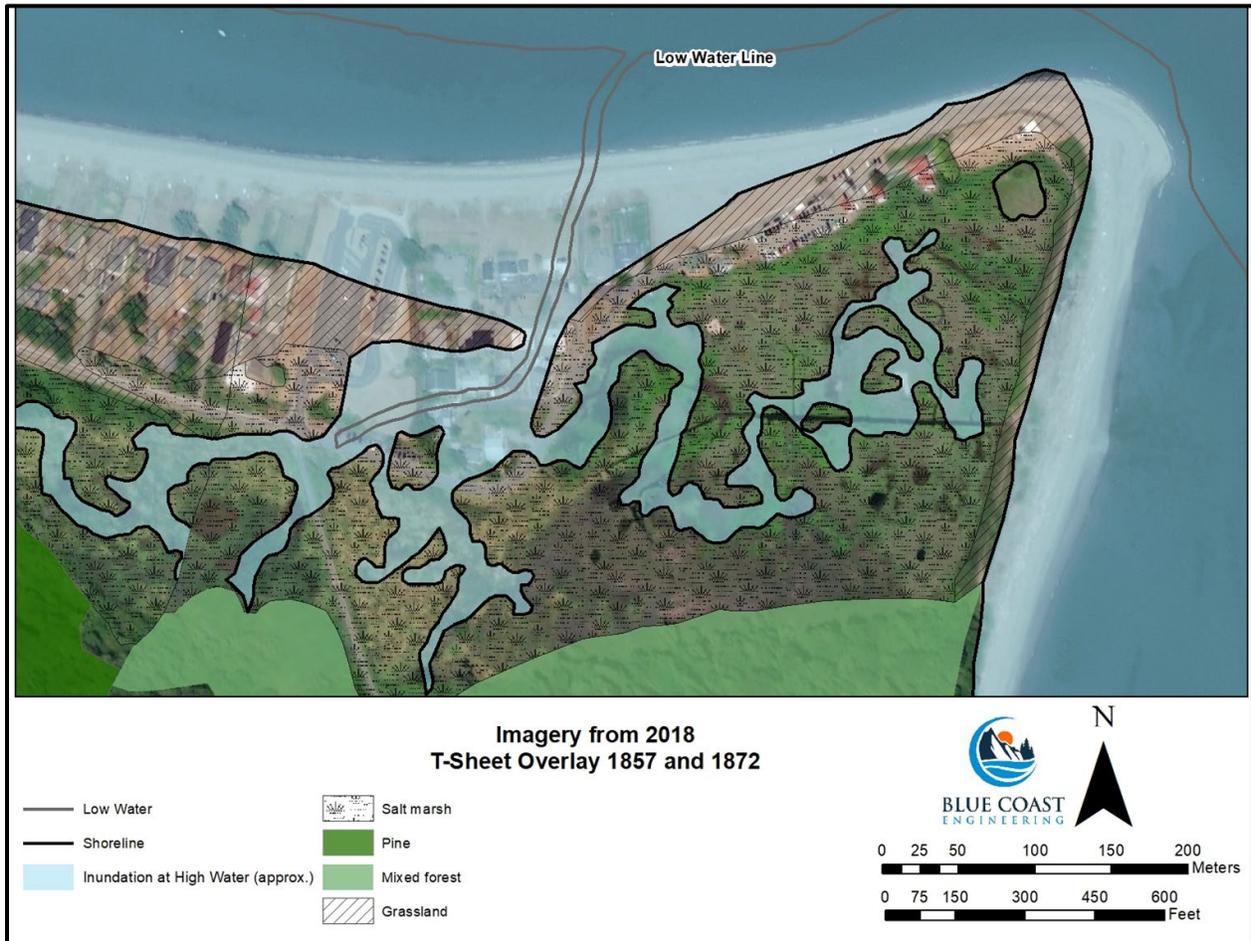
**Figure 2-1. Point No Point T-sheet overlay.**

- 415-foot-long sand beach along the northern shoreline of the park. This shoreline and private development to the west of the park are built on reclaimed (fill) land (see T-sheet overlay, Figure 2-1).
- Vegetated back beach area 20- to 175-feet wide with NE Point No Point Rd and parking adjacent to the south.
- Scattered large wood along the top of the beach.
- This is a heavily used recreational area within the park.
- Elevations (NAVD88<sup>3</sup>):
  - Top of beach: 11 to 12 feet
  - Back beach area: 9 to 11 feet
  - Point No Point Rd: 10 to 11 feet

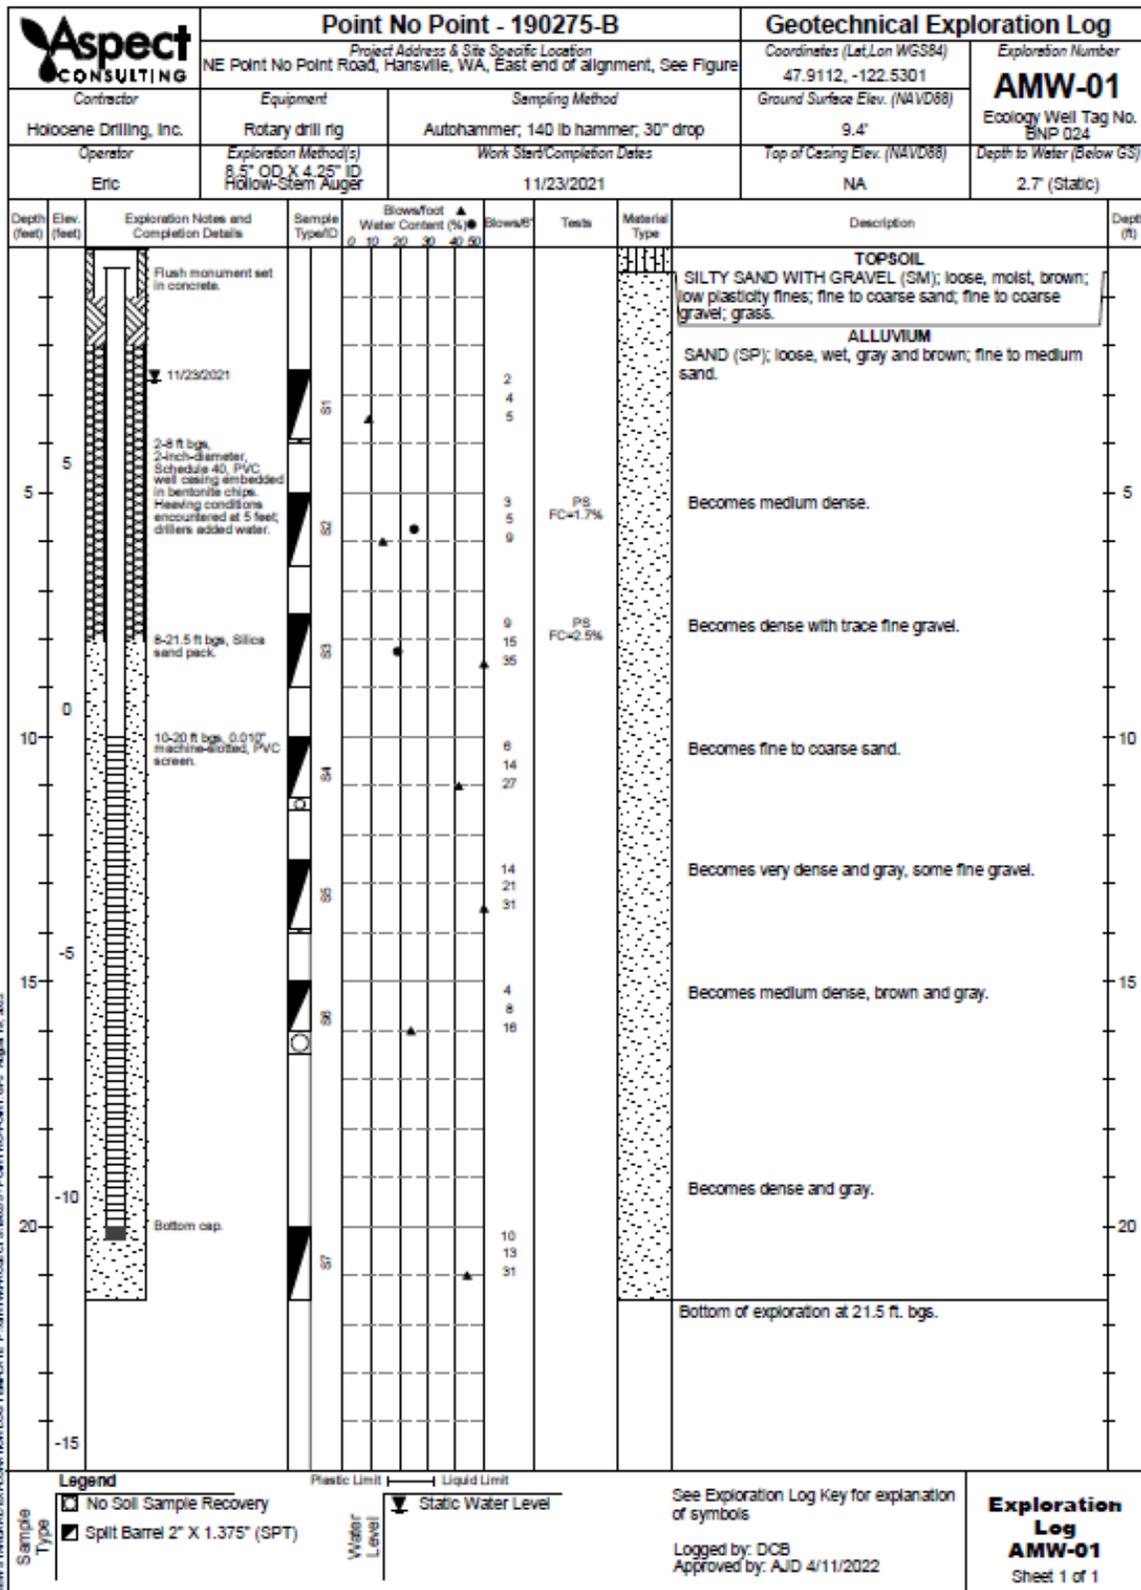
Figure 2-6. Exploration log for boring in Point No Point Road at park entrance (Aspect 2022).

Aspect Consulting (2022) conducted an exploration program to determine the soil properties in the Point No Point Park area as part of the Point No Point estuary restoration planning project being conducted by Blue Coast for MSFEG (Blue Coast 2023). The program included five drilled borings to extract sediment cores. Based on the borings, the project site is underlain by topsoil, fill, Holocene-age alluvium, and Holocene-aged, nonglacial, salt marsh deposits, which is in general agreement with the geologic maps of the area. Topsoil was found in the top 6 inches of the ground surface. Salt marsh deposits were encountered in two of the borings from 6 inches to approximately 5 feet below ground surface (bgs). Holocene-age alluvium (generally medium to coarse sand or silty sand) was found in all five borings below the saltmarsh deposits or below the fill in areas where no saltmarsh was found and extended to the depth of each boring (20 to 50 feet bgs). The boring in Point No Point Road near the park entrance (AMW-01) had 1 to 2 feet of topsoil underlain by fine to medium sand (Figure 2-6). Based on these borings and observations of the exposed eroded surfaces after the 2022 storm events, the north beach and below grade of the park is assumed to be medium to coarse sand down to at least 20 feet bgs.

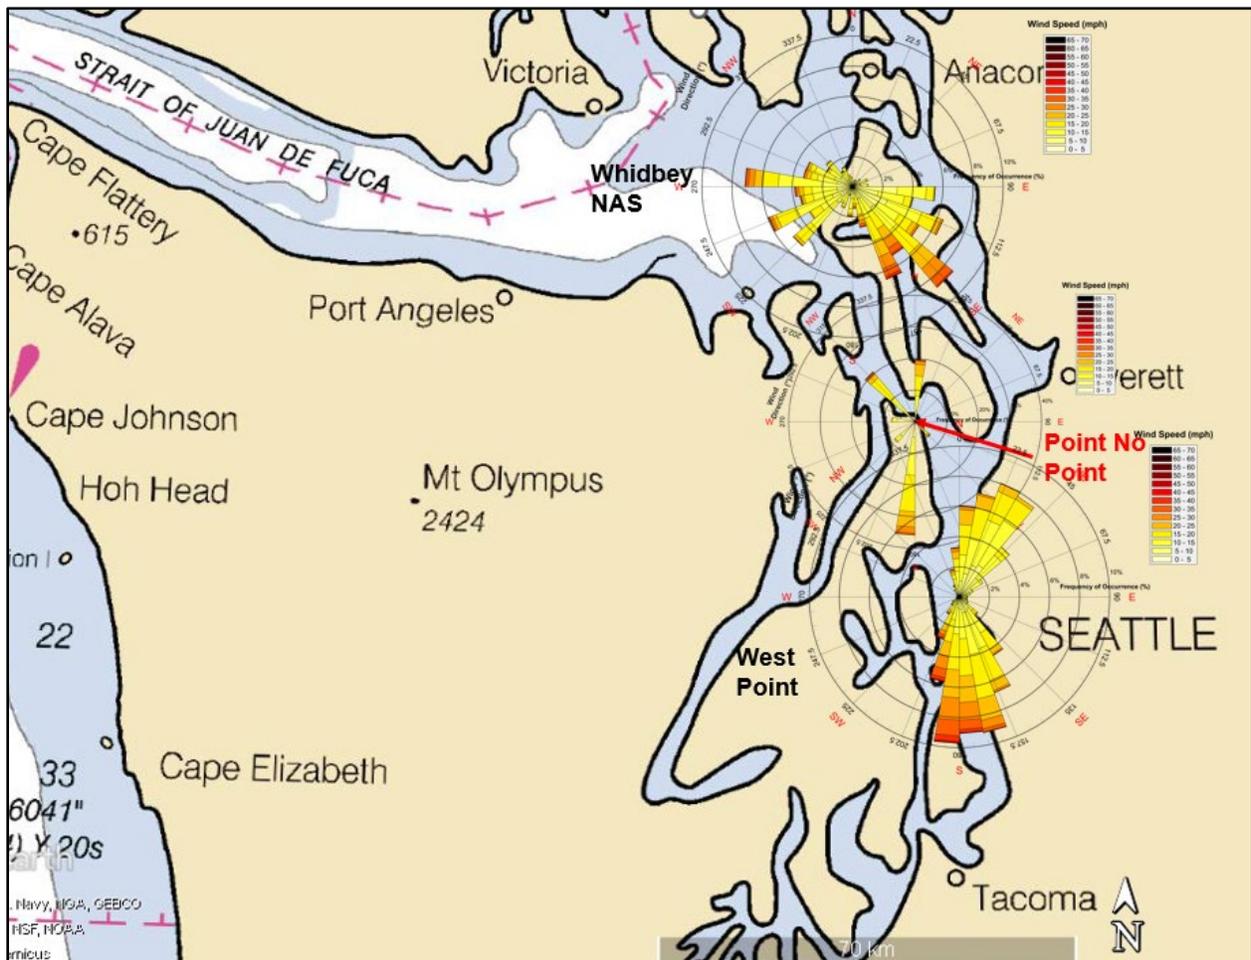
**Figure 2-7. Wind rose for the Whidbey NAS, Point No Point, and West Point meteorological stations overlain on a regional map. Direction is the direction from which wind is blowing.**

Wind roses for the wind records at the three stations are shown in Figure 2-7 superimposed on a map of the region. The wind roses show the bimodal wind distribution at each station, aligning with the local topography along the Strait of Juan de Fuca and Admiralty Inlet at Whidbey NAS, Admiralty Inlet (northwest), and central Puget Sound basin (south) at Point No Point, and along the main axis of the central Puget Sound basin (north to south) at West Point. The strongest winds measured at these stations are between 50 and 60 miles per hour (mph).

The limited wind record at Point No Point has significant data gaps and the direction measurements are poor resolution (45 degree increments), as illustrated by joint frequency of occurrence of wind speed and direction compared to Whidbey NAS (Tables 2-3 and 2-4). A review of the wind records indicates that for northerly and westerly winds, the Whidbey NAS station is most representative of conditions at Point No Point, and for southerly winds, West Point is most representative of conditions at Point No Point.

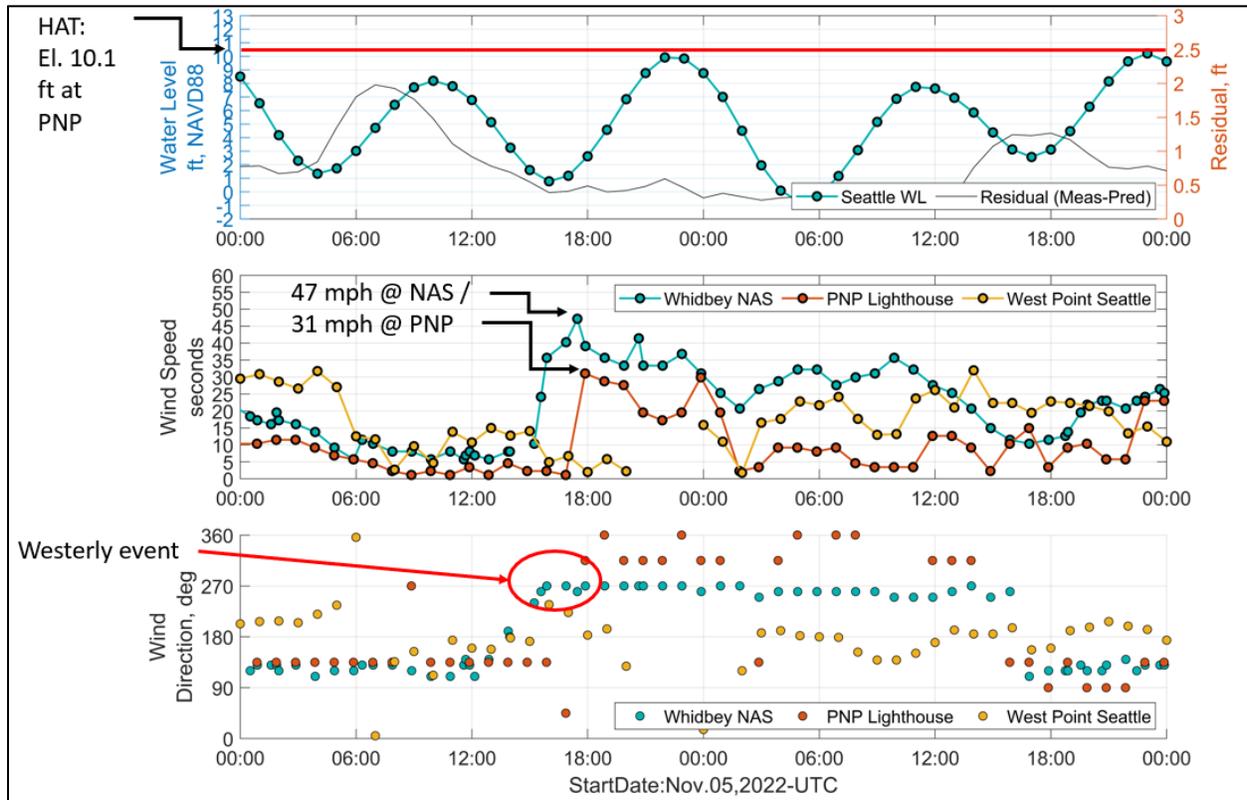
**Figure 2-8. Time series of November 2022 wind event with measurements from Whidbey NAS, Point No Point Lighthouse, and West Point (Seattle). Water level record is from the Seattle station.**

A wind-wave hindcast was completed to estimate the wave conditions at Point No Point during the November 2022 storm event (Section 2.1.2), which resulted in the formation of a 2- to 3-foot scarp near the top of the beach. Wind speeds (Figure 2-8) during the event peaked around mean tide levels (3 to 4 feet NAVD88) at 47 mph at Whidbey NAS and 31 mph at Point No Point. Based on the extreme value analysis for Whidbey NAS, this was the equivalent to a 25-year or 50-year return interval event considering 95% confidence interval for northerly winds. Corresponding wind speeds at West Point were low (<10 mph), reflecting the topographic differences across Puget Sound. Wind direction at Whidbey NAS was westerly while at Point No Point it was northerly.

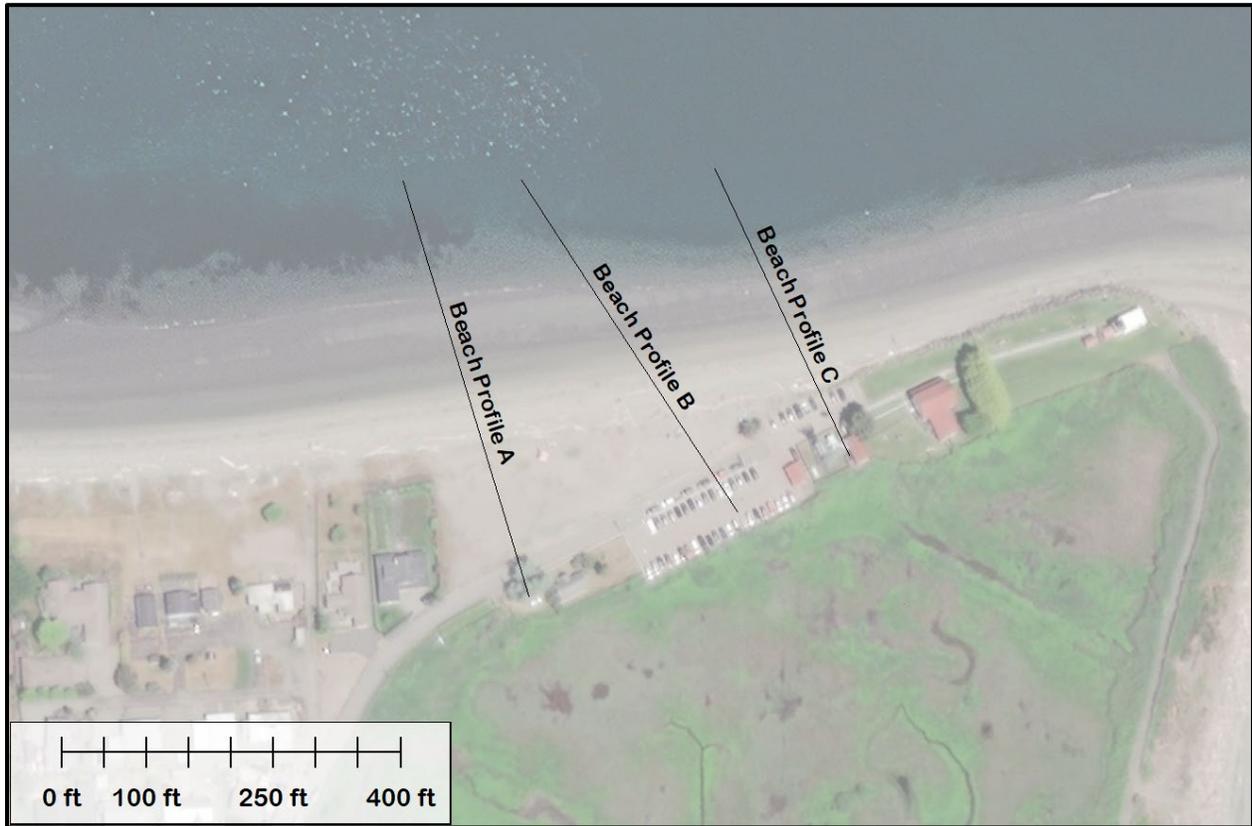
**Figure 2-9. Point No Point beach profile locations used in XBeach model.**

Wave run-up is the landward extent of wave uprush measured vertically from the still water level and is an important consideration for the vertical extent of flood protection mitigation measures. Wave run-up was estimated for the November 2022 wind-wave event at three transect locations using XBeach (Figure 2-9). XBeach (non-hydrostatic) is a depth-averaged cross-shore one-dimensional model that predicts nearshore hydrodynamics and can be used to predict wave run-up under storm conditions (Roelvink et al. 2015, McCall et al. 2010). The non-hydrostatic module extends XBeach’s capability to model non-linear waves and waves breaking in the surf zone. Wave run-up is highly dependent on slope of the beach or structure on which the wave runs up. The beach slopes were calculated based on the 2017 LiDAR topographic survey to be between 8:5:1 and 9.5:1 (Table 2-7) prior to the 2022 storm event. The wave parameters for the November 2022 event estimated using CEDAS ( $H_s = 4.5$  feet,  $T_p = 4.3$  seconds) were input into the model as the offshore boundary condition and the 2017 LiDAR was used as the input surface.

Beach Profile	Slope (H:V) between MTL & HTL	Stillwater level (feet NAVD88)	Wave run-up $R_{2\%}$ (feet)	Total water level (feet NAVD88)
A	9.5:1	4.4	2.0	6.4
B	9:1	4.4	2.1	6.5
C	8.5:1	4.4	2.2	6.6

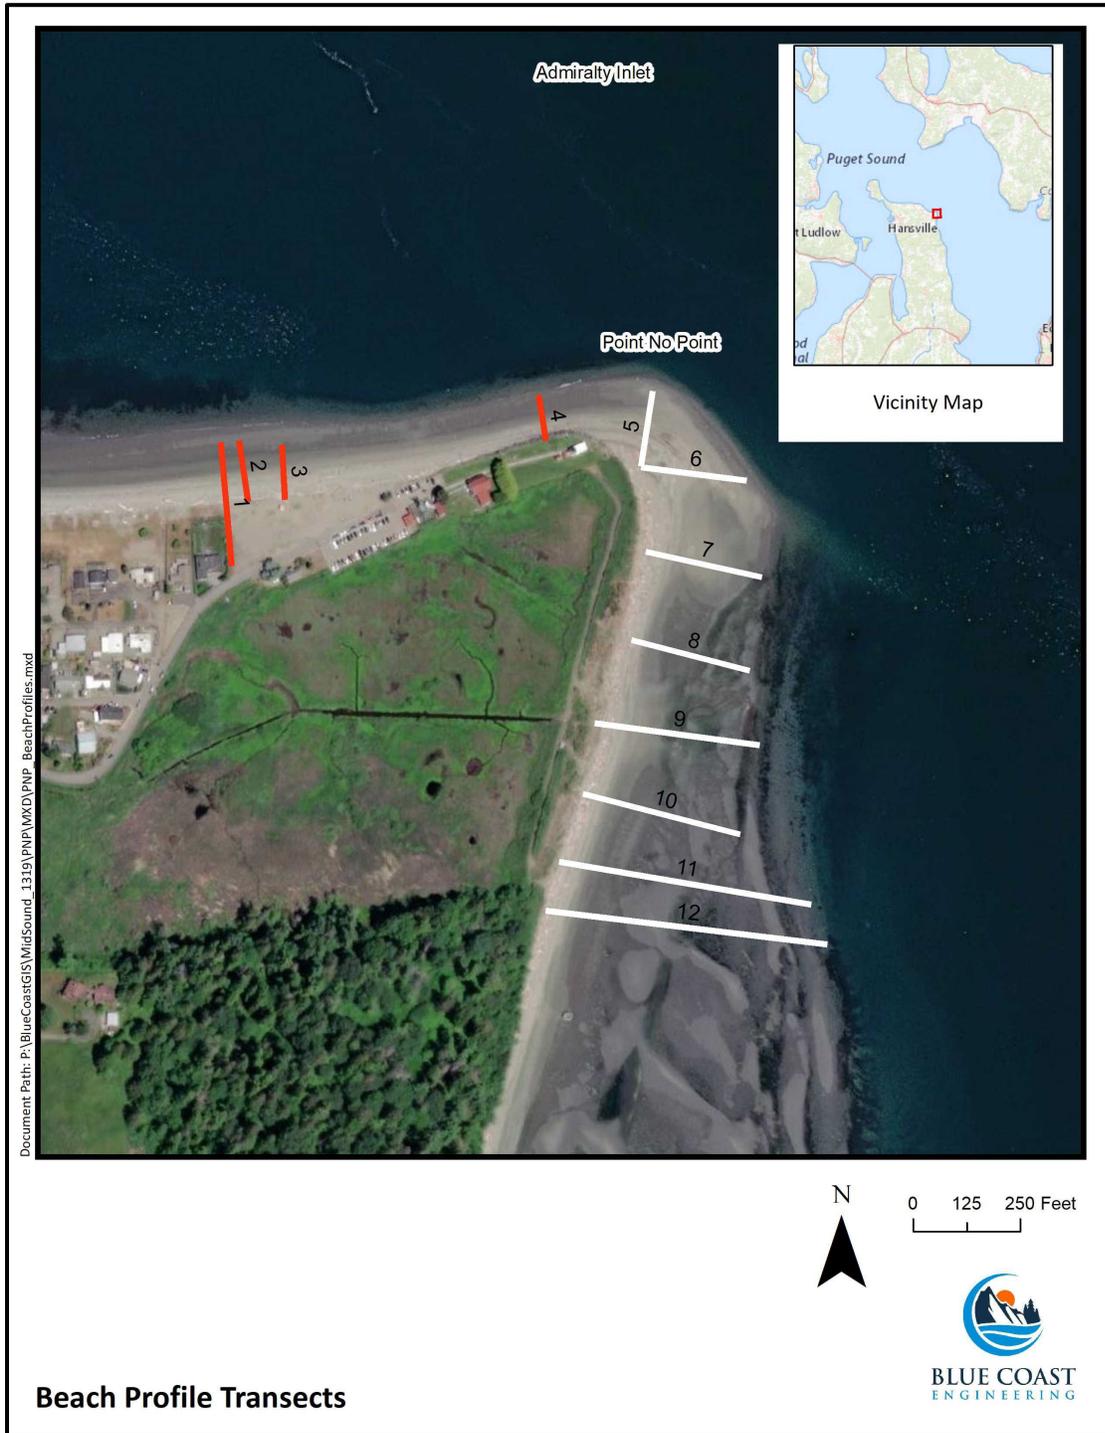
**Figure 2-11. Point No Point beach profile monitoring locations. Northern shoreline profiles highlighted in red.**

To better understand the morphologic response of shoreline, Blue Coast evaluated beach profile monitoring data collected as part of the restoration project since 2018. Topographic elevation data have been obtained at up to 12 shore-perpendicular survey transects (profiles), including four along the northern shoreline (highlighted in red on Figure 2-11). Data were collected using a Trimble R-10 Global Positioning System (GPS) receiver corrected in real time to a high-precision position using the Washington State Reference Network (WSRN) Continuous Operating Reference Station (CORS) accessed through cellular service. Survey points were collected every 5 to 10 feet along the transects and at breaks in grade and changes in substrate or feature type.

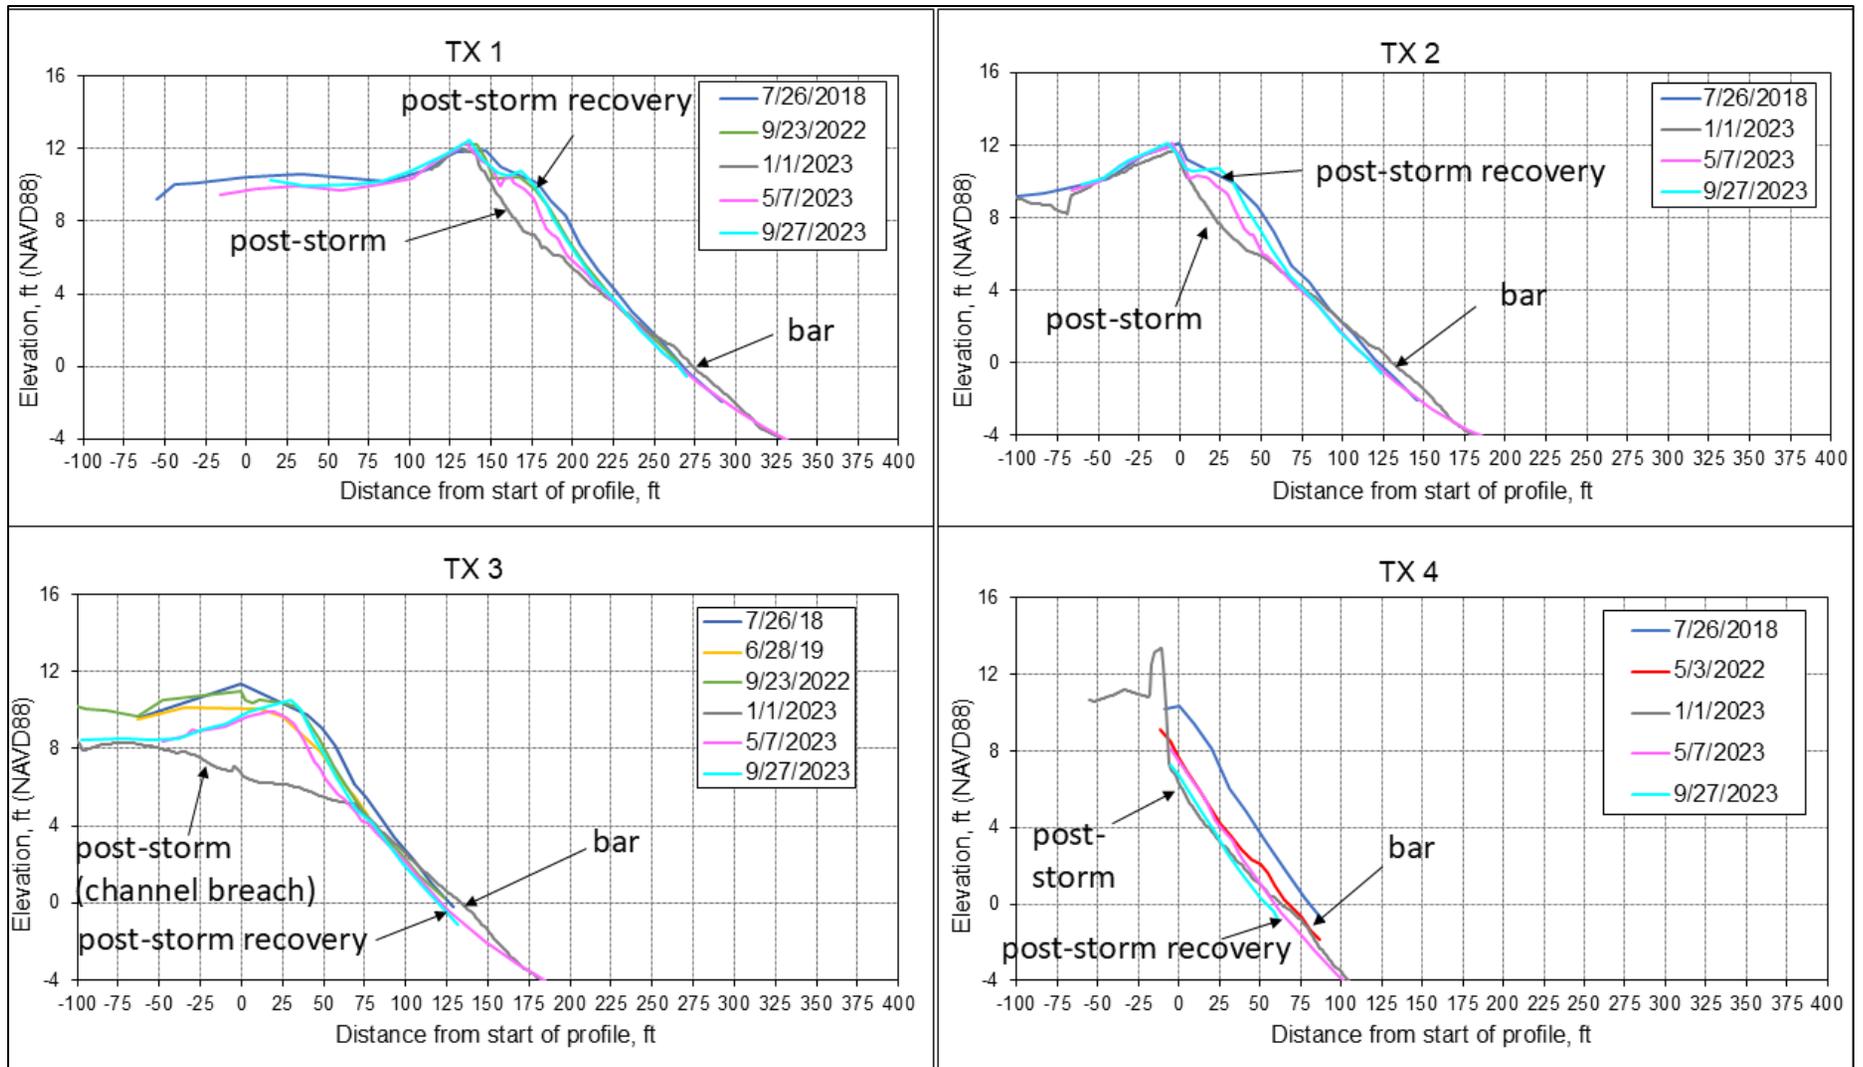
**Figure 2-12. Beach monitoring profile plots. Note**

Results from the available monitoring data for transects 1 to 4 (located along the northern shoreline) are provided in Figure 2-12 and compared to the recent 2023 topographic survey completed by Kitsap County. -Surveys collected on the following dates were used in this analysis:

The beach in front of the revetment experienced a drop in elevation of approximately 2 feet between May 2022 and January 2023 as a result of the storm events. There is evidence of a cross-shore bar in the January 2023 survey at the revetment, which does not appear in the May 2023 and the upper beach between January and May 2023 increased in elevation to almost the pre-storm profile in front of the revetment. However, the September 2023 profile indicates erosion of profile in front of the revetment.

Because of the significant changes in the beach to the west of the revetment, the sediment dynamics at the site are complicated during recovery and vary from location to location. Prior to the breach in the north beach, sediment transported alongshore from the west to the east could reach the point and be deposited in front of the revetment. After the 2022 storm events, alongshore sediment will be deposited in the low area where the channel formed first and fill the lowered beach profile in front of the curb to the west of the revetment secondly. The accretion of the beach profile in front of the revetment between January and May are likely the result of cross shore transport of the sediment stored in the bar moving onshore, but by September the sediment in the bar had been redistributed, and sediment being transported alongshore could not make it to the revetment resulting in erosion of the profile between May and September 2023.

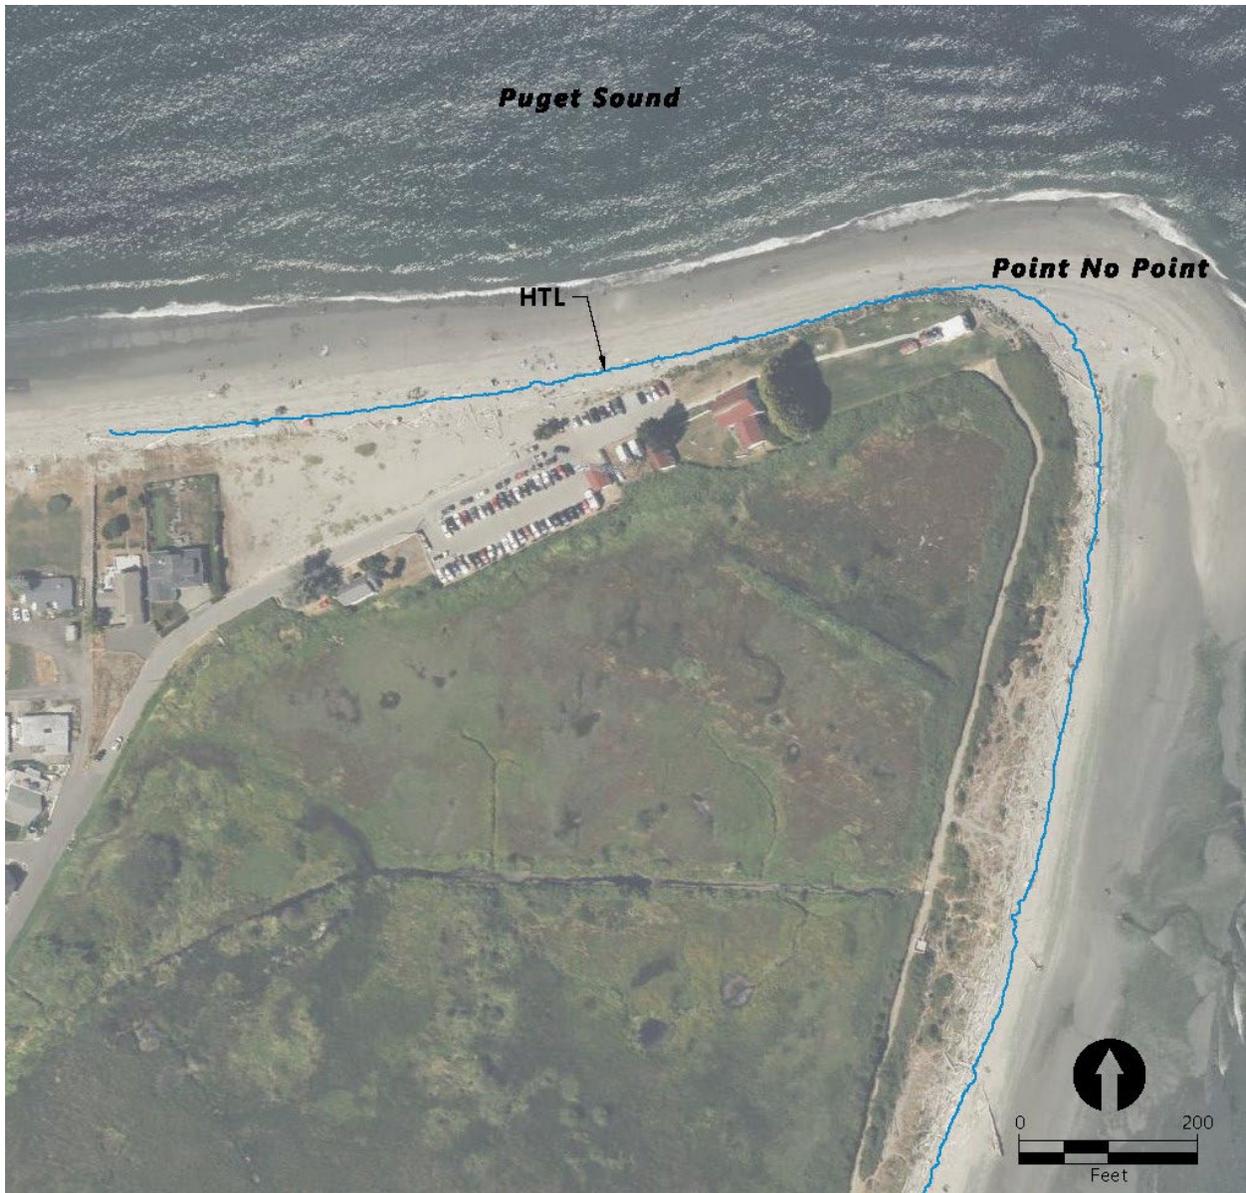
**Figure 1. Project site overview showing calculated High Tide Line, imagery from August 2022.**

Figure 1 shows the OHWM delineated by using aerial imagery from August 2022. The average elevation of the OHWM delineated using aerial imagery along the north beach and revetment is 12.7
