# **Kitsap County** Americans with Disabilities Act (ADA)

# Transportation Facilities Transition Plan

Prepared by Transpo Group

December 2024

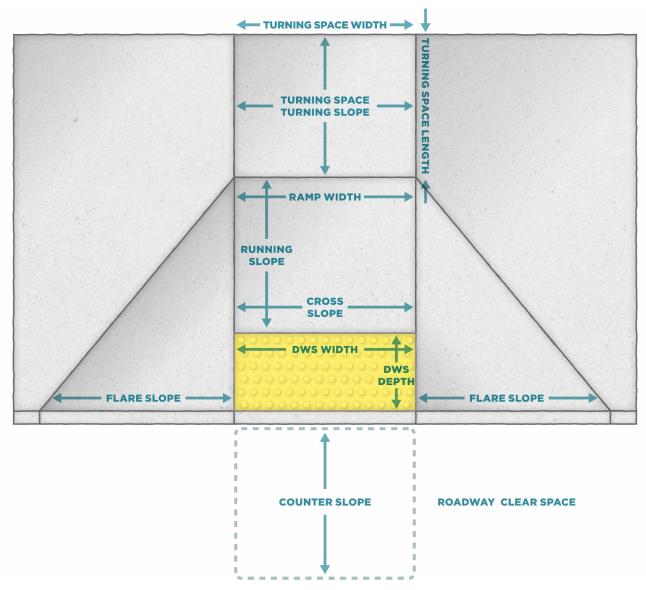
Figure 2.3 Perpendicular Curb Ramp Attributes

#### **Curb Ramps**

- 0: Compliant.
- 1-29: Minor Compliance Issue.
- 30: Significant Compliance Issue.

These scores are referred to as the Accessibility Index Score (AIS). Curb ramps that had running slopes that were too steep received a score of 30 and were considered non-compliant. Curb ramps that had cross slopes slightly above the compliant threshold received a score of 20 while steeper cross slopes received a 30.

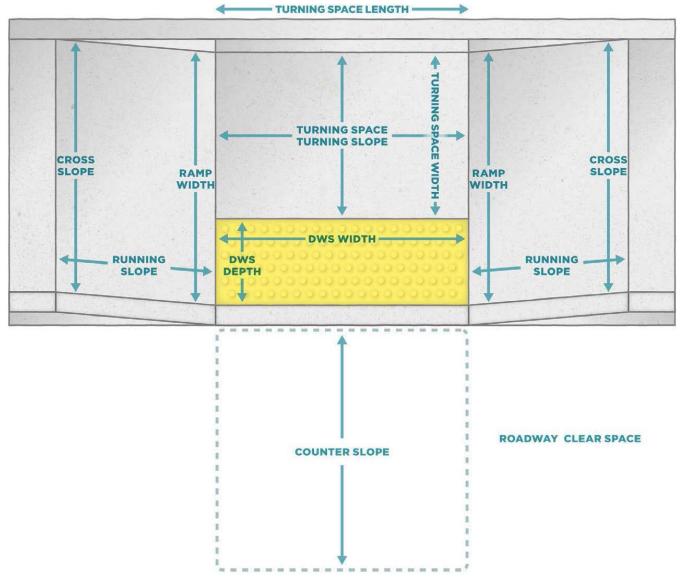
Figure 2.4 Parallel Curb Ramp Attributes

Other criteria relating to turning space, flare slopes, detectable warning surfaces (DWS), obstructions, and condition were weighted lower, but could cumulatively reach the threshold for non-compliance.

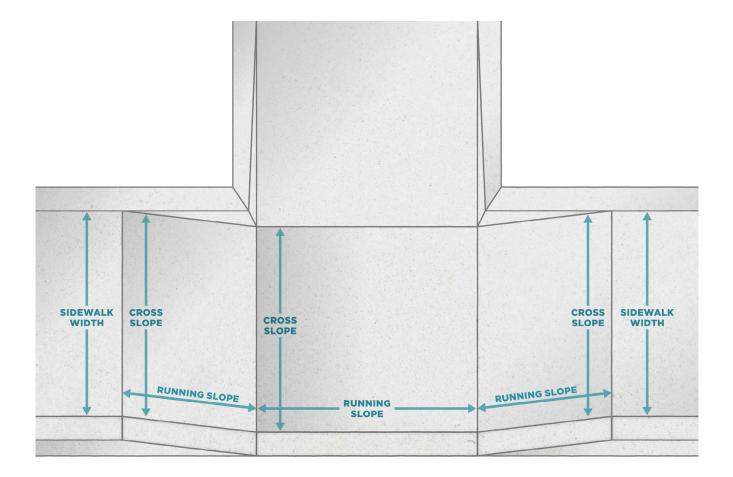
#### Figure 2.5 Sidewalk Attributes

#### **Sidewalks**

- Width, i.e., the sidewalk is too narrow.
- Slope, i.e., the sidewalk run slope or cross slope is too steep.
- Condition, i.e., the amount of cracking, upheaval, or other deterioration.

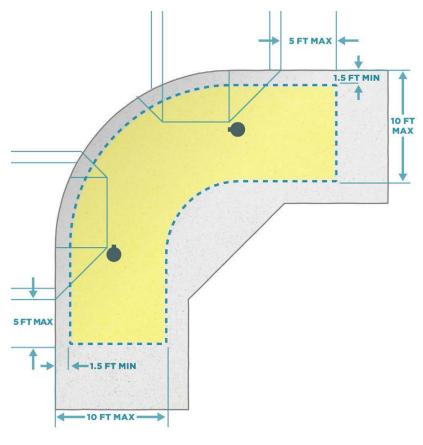
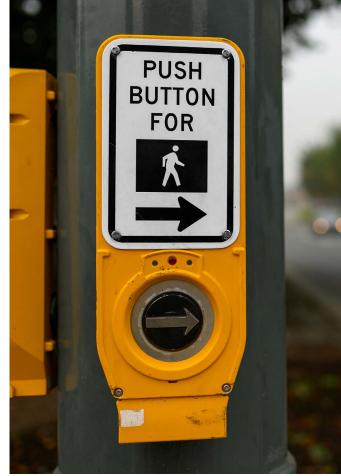
Figure 2.6 APS Pedestrian Push Button and Push Button Location Attributes

Data for pedestrian signal push buttons was collected by Transpo Group staff and Kitsap County. Accessible pedestrian signal push buttons (APS) provide integrated visual, audible, and vibrotactile information to help pedestrians cross signalized intersections. Some push buttons can be programmed to request an extended crossing time or to make the name of the street being crossed audible when pushed for a longer time.

Push button scores ranged from 0-30 and were categorized as follows:

- 0: Compliant.
- 1-15: Minor Compliance Issue.
- 16-30: Significant Compliance Issue.

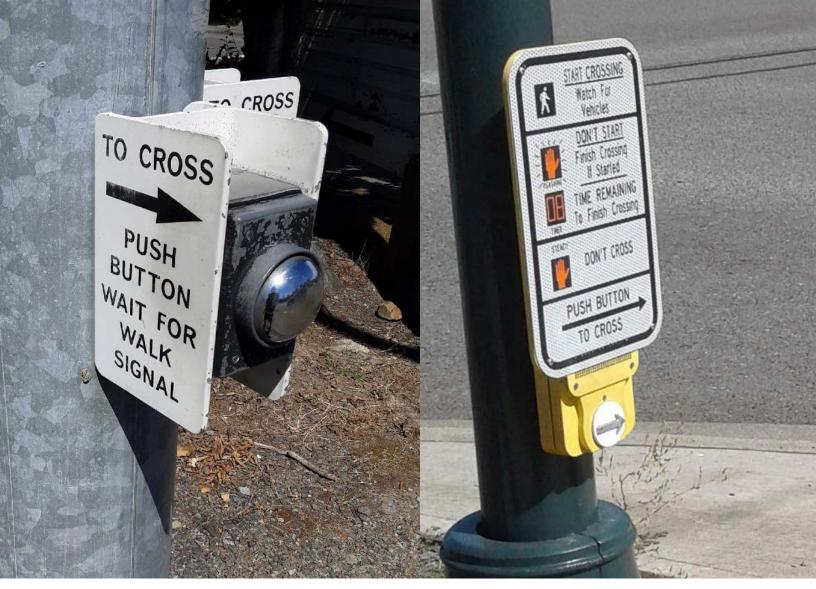
Figure 2.17 "H-style" And APS-style Pedestrian Push Button

Of the 334 inventoried pedestrian push buttons, 196 were non-APS style. Non-compliant pedestrian push buttons include non-APS style buttons to be replaced and APS-style buttons to be reprogrammed or relocated.

County. This style of push button can be upgraded to increase accessibility but must be fully replaced with an accessible pedestrian signal (APS)-style push button to achieve full ADA compliance (Figure 2.17).

The requirement to use APS-style push buttons is relatively new, and lack of compliance is typically due to a crossing not being upgraded prior to evolving requirements. Push buttons are most often upgraded to APS-style in groups rather than individually. As a result, APS-style additions and upgrades usually occur on an intersection-by-intersection basis.

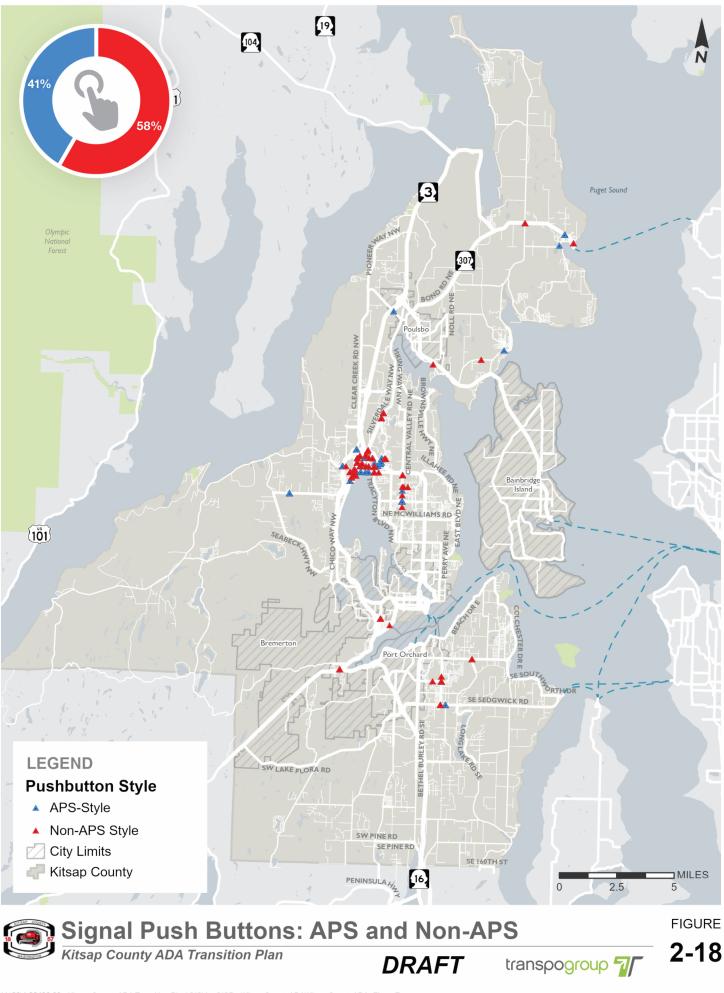
Figure 2.18 shows the type and locations of pedestrian push buttons throughout the county.

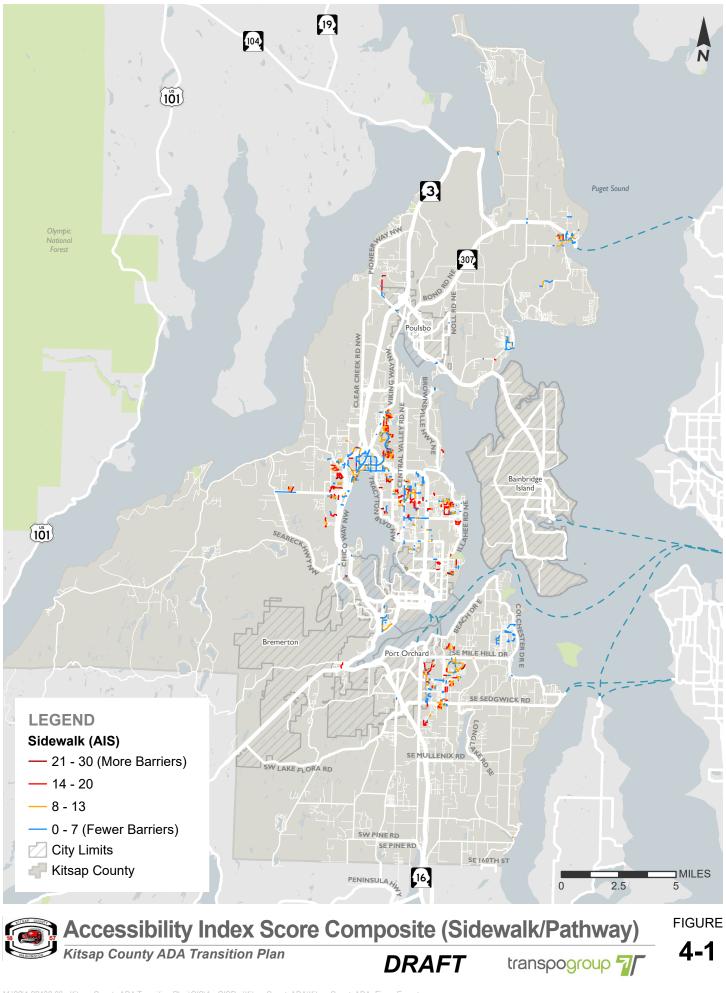
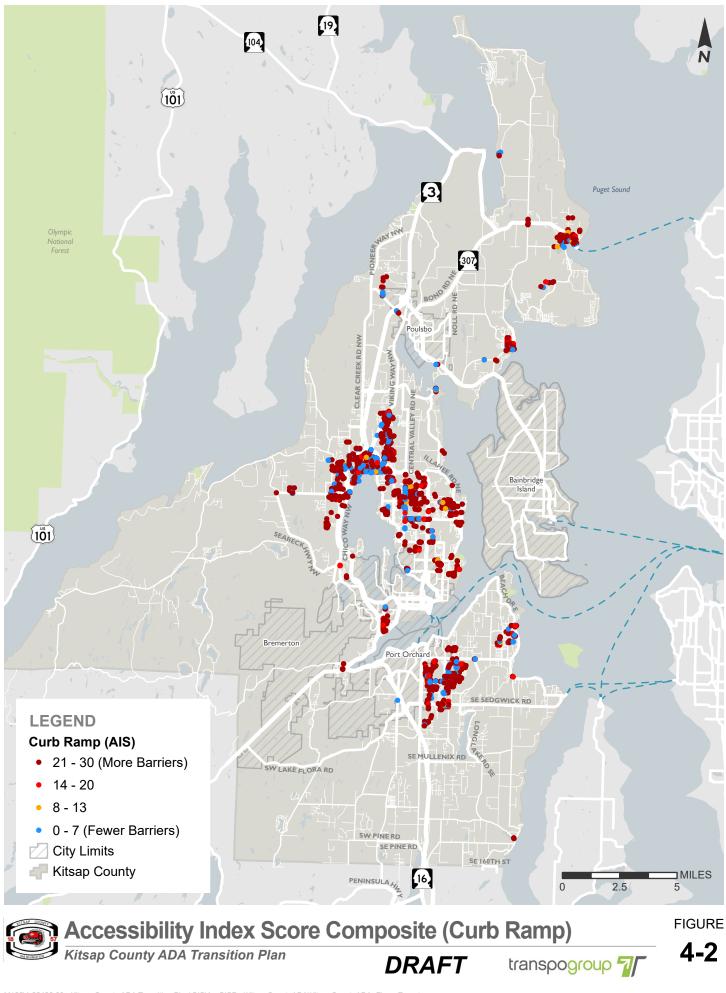
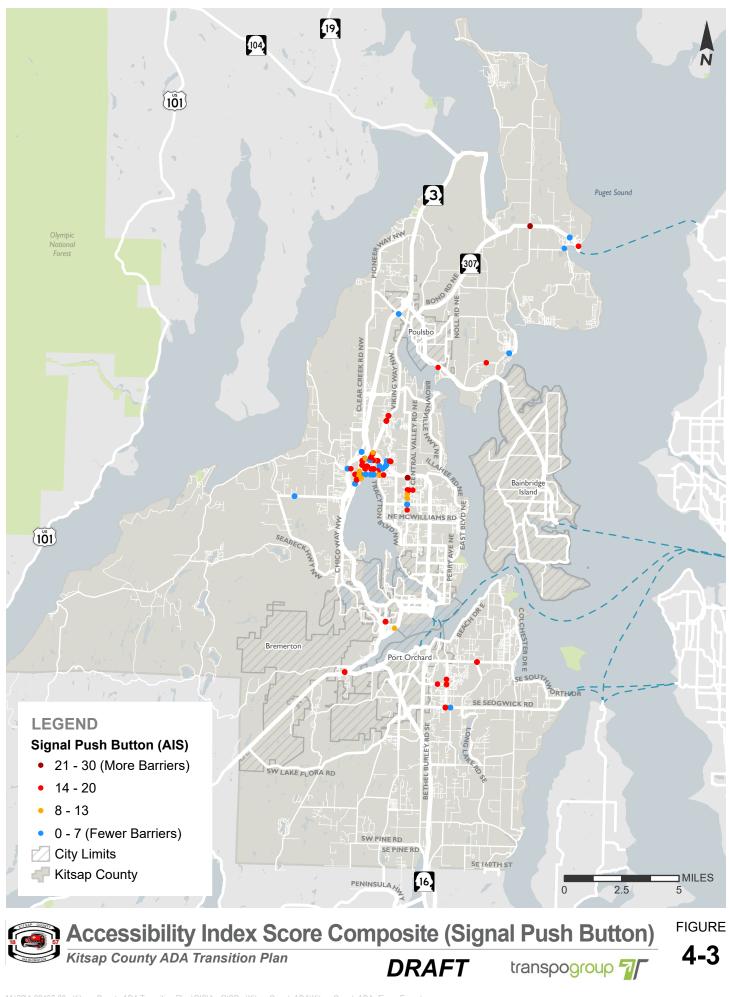
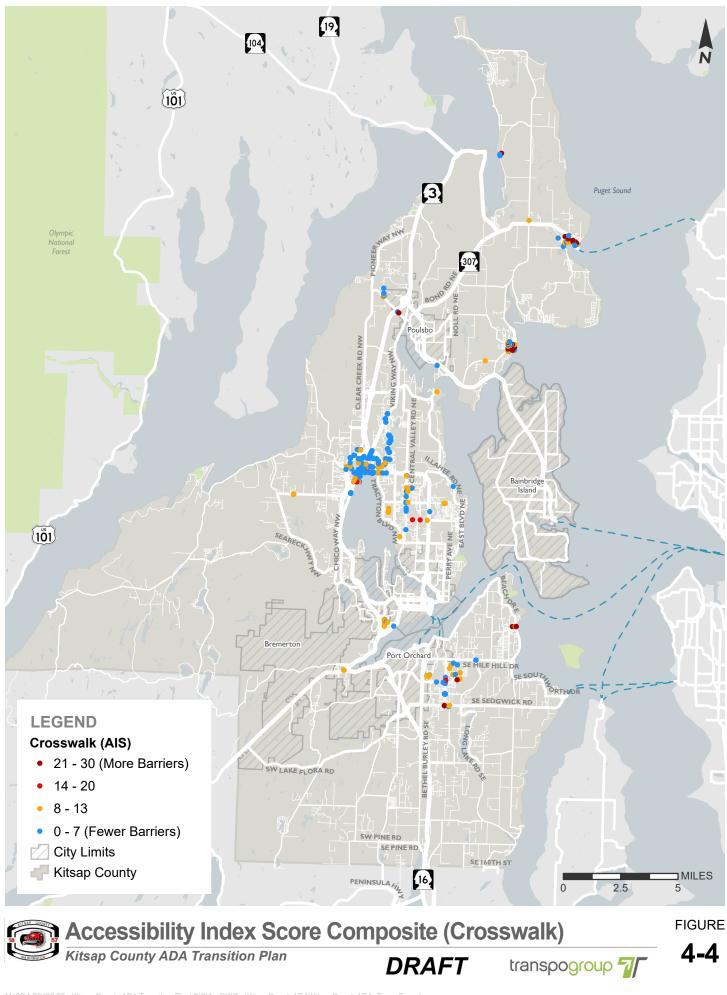
Potential scores for each facility range from 0 (compliant) to 30. Each facility's Accessibility Index Score is the sum of the individual criterion scores.

Figures 4.1 through 4.4 show the AIS for each of the facilities where data were collected.

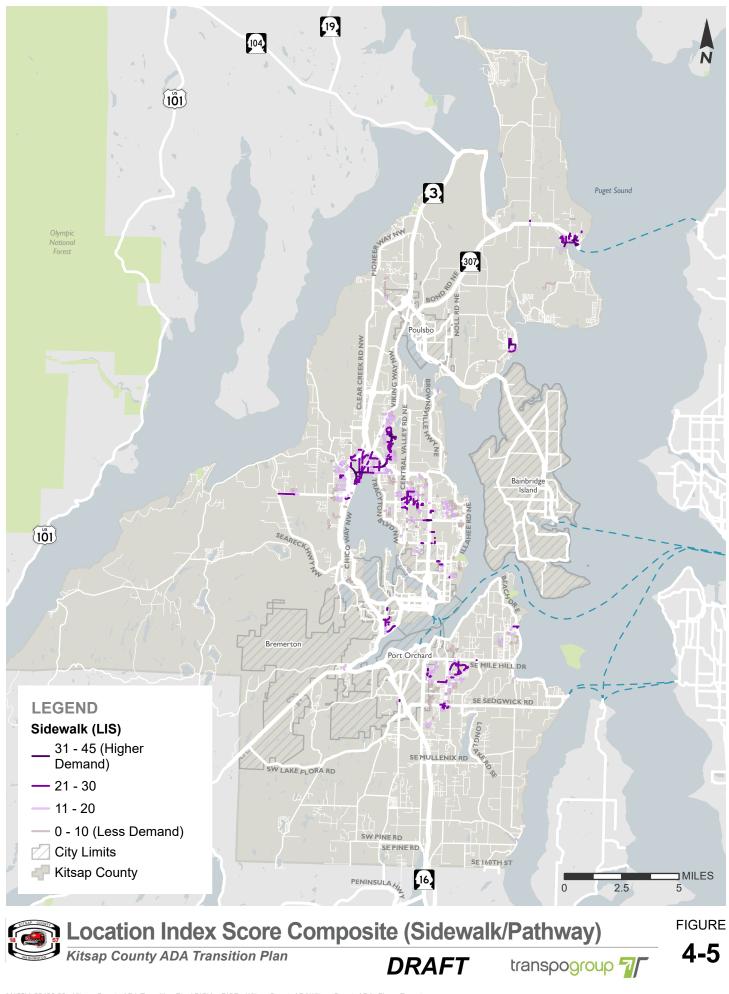
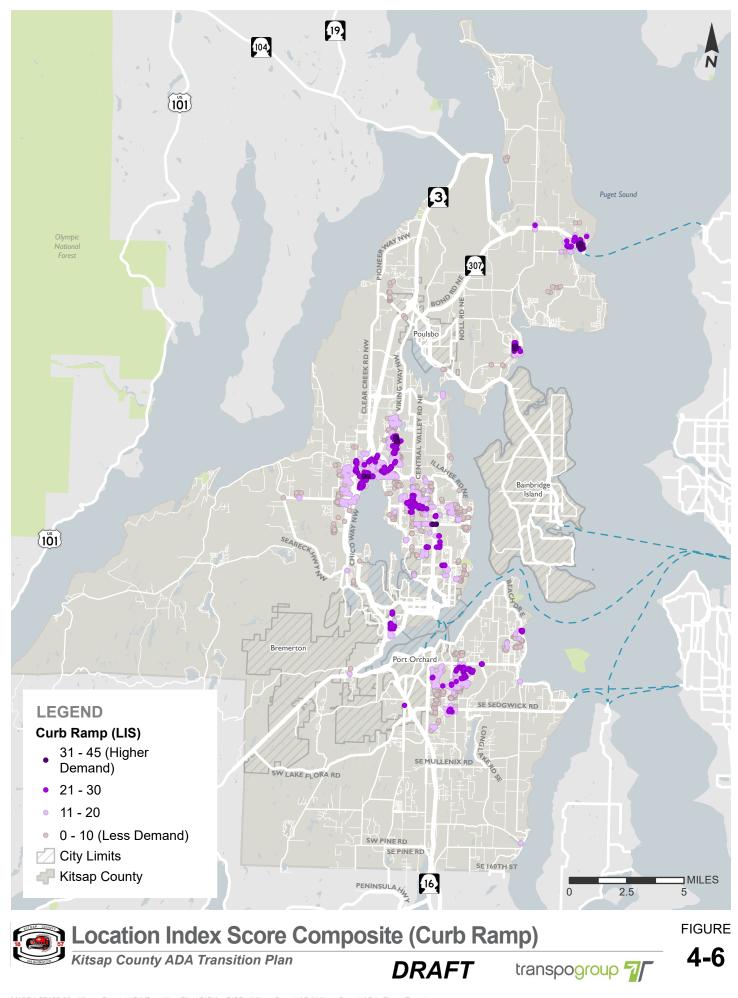
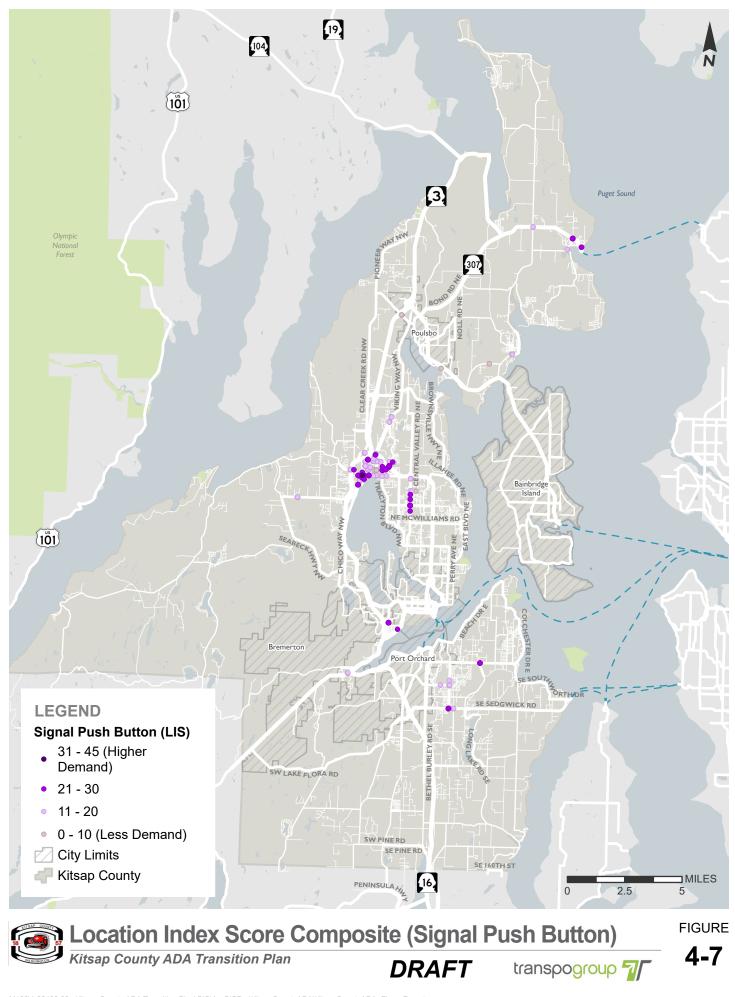
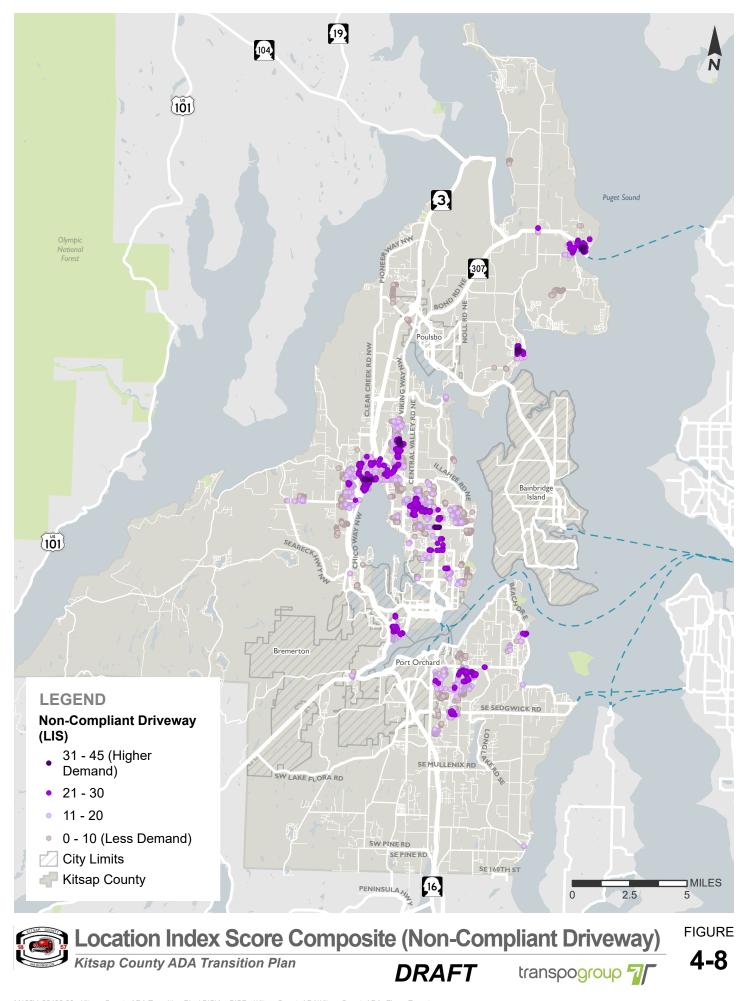
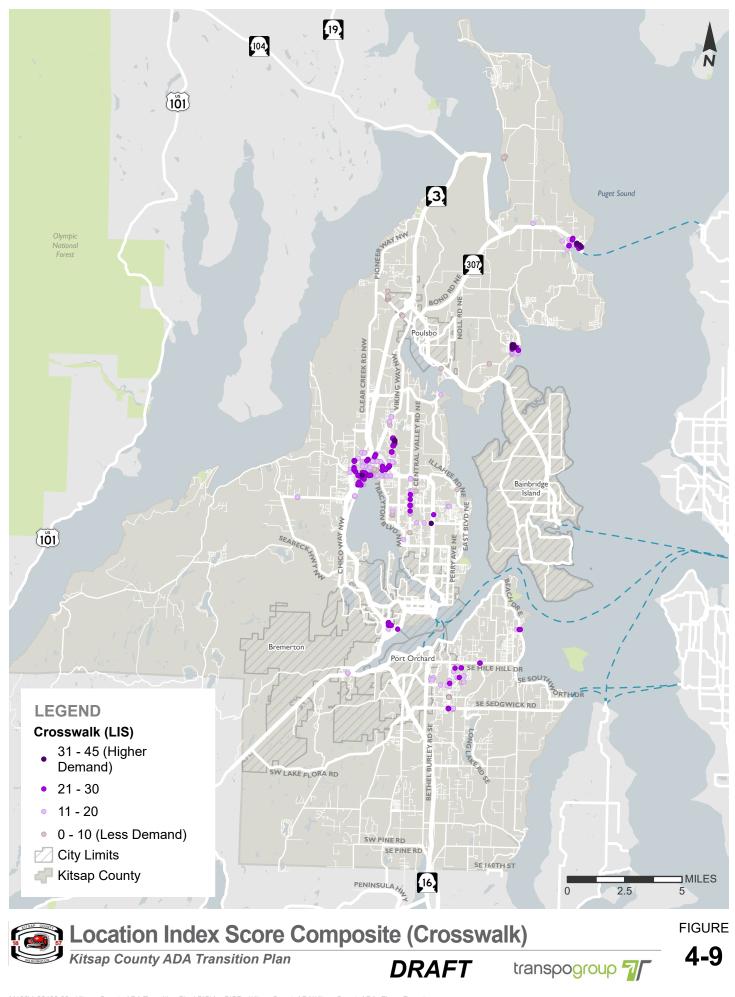
The Location Index Score describes the importance of the pedestrian facility in accessing key community destinations. Each existing pedestrian facility was scored based on its proximity to schools, parks, transit facilities, signals or roundabouts, public buildings, and downtown or commercial business centers. Facilities near government buildings, hospitals and medical facilities, and retail services received a higher score to reflect feedback received through the public engagement survey.

Total Location Index Scores ranged from 0 to 45. Location scoring criteria and weights are shown in Appendix C.

Figures 4.5 through 4.9 show the LIS for each of the facilities where data were collected.

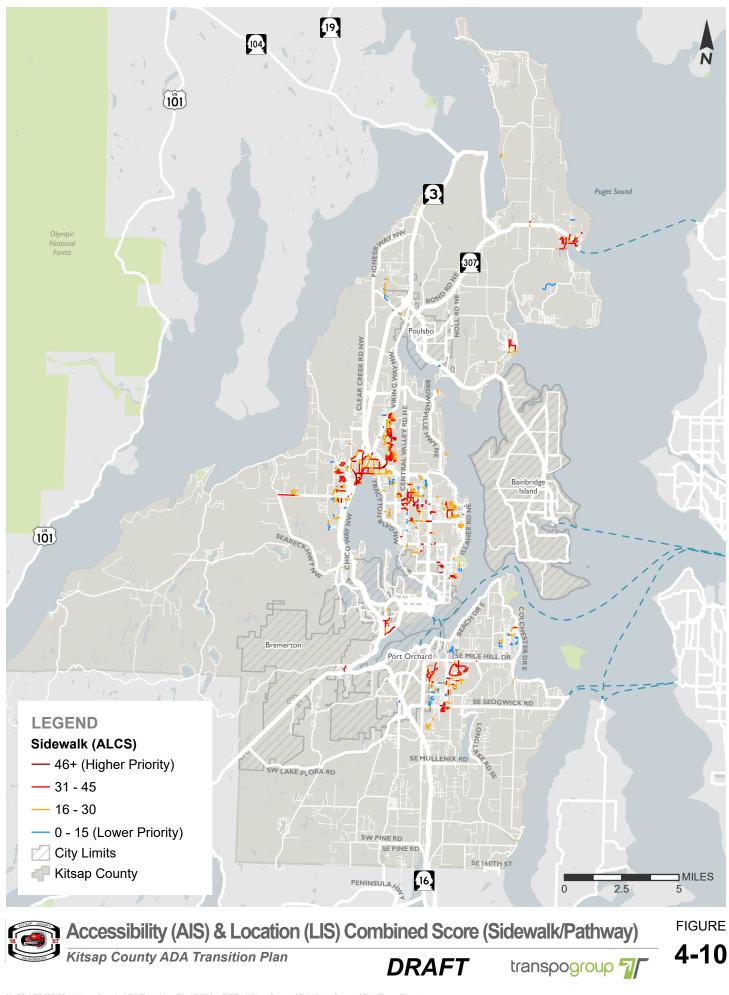
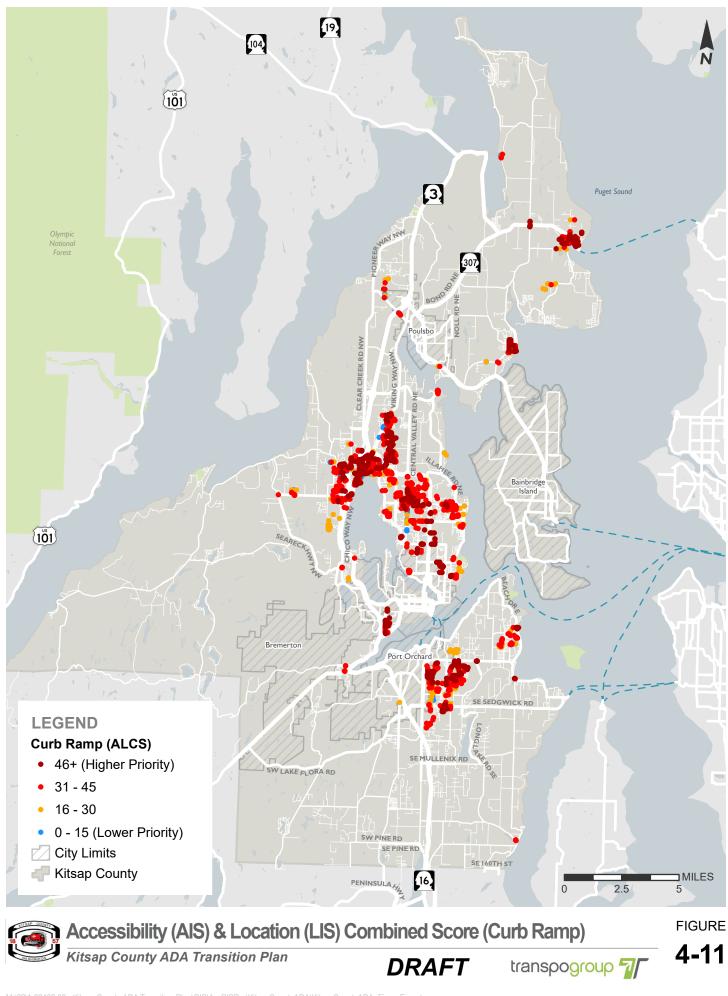
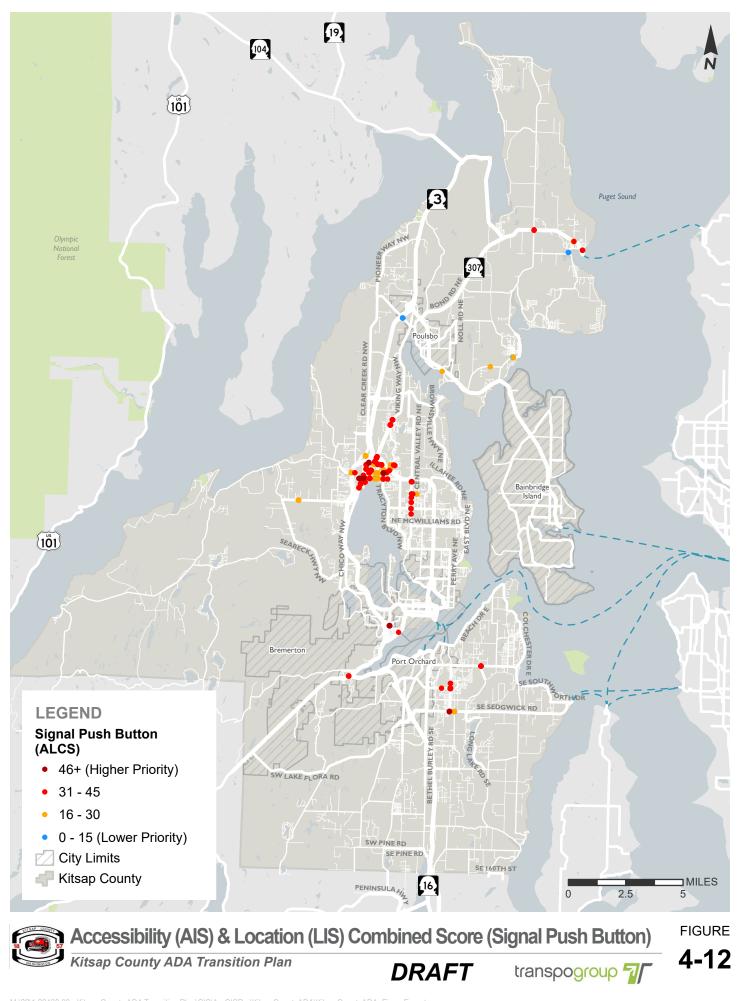
The Combined Index Score sums the Accessibility Index Score and Location Index Score to prioritize facilities with accessibility barriers in areas where pedestrians would be expected.

- Very High significant physical barriers and a high number of hazards in high-demand areas: 46+ points.
- High significant physical barriers in highdemand areas: 31-45 points.
- Medium 16-30 points.
- Low minor barriers in low-demand areas:1-15 points.

Figures 4.10 through 4.12 show the combined scores for each of the facilities where data were collected.
